ARBORIST'S GENERAL SUMMARY EXISTING TREE INVENTORY

South Trask Street Project

REPORT OF FINDINGS

SOUTH TRASK PROJECT

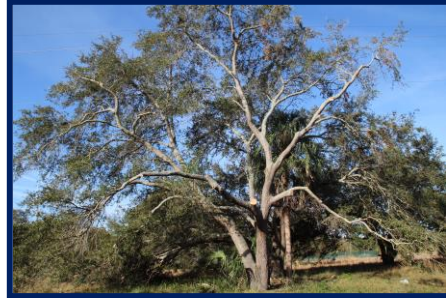
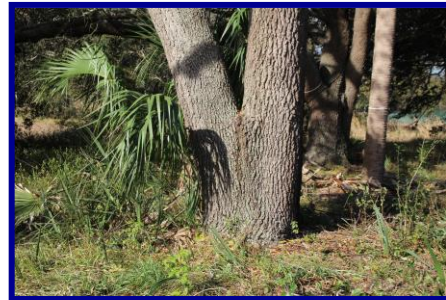
GRAND TREE EVALUATION	CONDITION
TREE # 1	
LIVE OAK 33" DIAMETER	NOT GRAND
TREE CONDITION EVALUATION	
ROOTS	B
TRUNK	C
LIMB/BRANCH STRUCTURE	B
TWIGS	B
FOLIAGE	B
HAZARD RATINGS	
FAILURE POTENTIAL	3
DEFECT SIZE	3
TARGET	2
Matheny/Clark Formula	8C

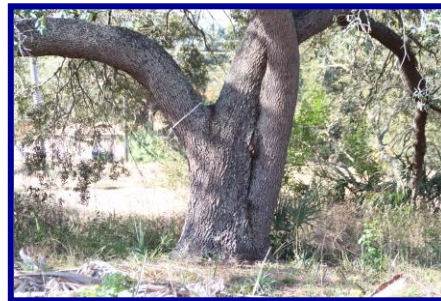
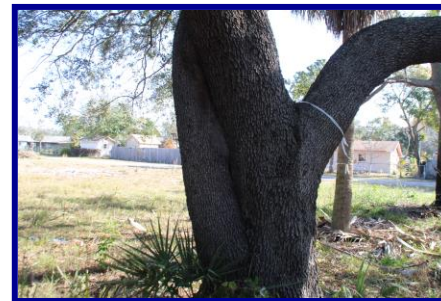
GRAND TREE EVALUATION	CONDITION
TREE # 2	
LIVE OAK 35" DIAMETER	NOT GRAND
TREE CONDITION EVALUATION	
ROOTS	B
TRUNK	D
LIMB/BRANCH STRUCTURE	B
TWIGS	B
FOLIAGE	B
HAZARD RATINGS	
FAILURE POTENTIAL	3
DEFECT SIZE	3
TARGET	2
Matheny/Clark Formula	8D

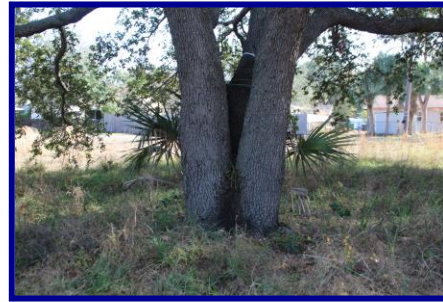
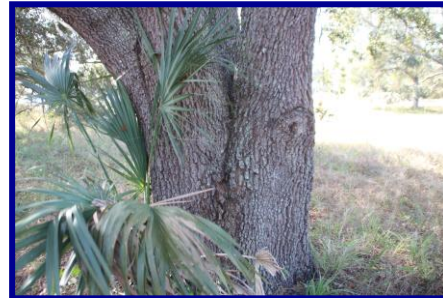
GRAND TREE EVALUATION	CONDITION
TREE # 3	
LIVE OAK 42" DIAMETER	GRAND
TREE CONDITION EVALUATION	
ROOTS	B
TRUNK	D
LIMB/BRANCH STRUCTURE	A
TWIGS	A
FOLIAGE	A
HAZARD RATINGS	
FAILURE POTENTIAL	3
DEFECT SIZE	3
TARGET	1
Matheny/Clark Formula	7D

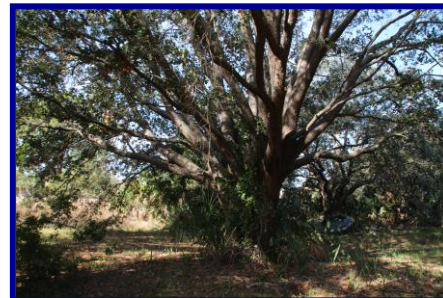
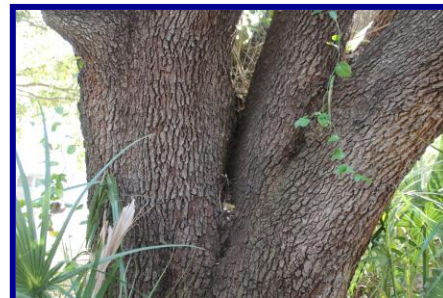
GRAND TREE EVALUATION	CONDITION
TREE # 4	
LIVE OAK 42" DIAMETER	GRAND
TREE CONDITION EVALUATION	
ROOTS	B
TRUNK	D
LIMB/BRANCH STRUCTURE	C
TWIGS	B
FOLIAGE	A
HAZARD RATINGS	
FAILURE POTENTIAL	3
DEFECT SIZE	4
TARGET	1
Matheny/Clark Formula	8D

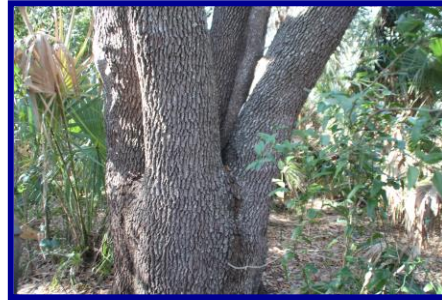
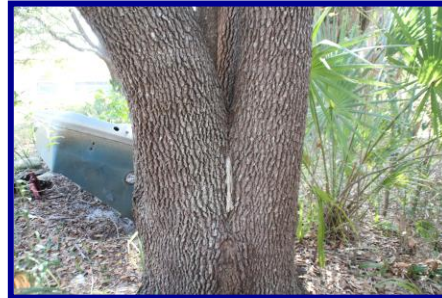
5	LIVE OAK	38	119	37	156	75	63	69	17.25	173.25	N	NOT GRAND, CODOMINANT 4 TRUNKS, ALL TRUNKS HAVE INCLUDED BARK, ROPE EMBEDDED IN 3 OF THE INCLUSIONS, UPPER CANOPY DIEBACK, ALL TRUNKS GROWING AWAY FROM MAIN TRUNK
6	LAUREL OA	37	116	39	155	68	64	66	16.5	171.5	N	NOT A GRAND, MULTIPLE BRANCHES EMANATING FROM ONE POINT ON TRUNK, APPEARS TO HAVE BEEN CENTER PRUNED IN PAST
7	LIVE OAK	38	119	36	155	78	83	80.5	20.125	175.125	Y	CODOMINANT WITH STRONG U SHAPED ATTACHMENTS, DIEBACK
8	LIVE OAK	38	119	39	158	6	61	33.5	8.375	166.375	N	CODOMINANT WITH INCLUDED BARK, AREA OF INCLUSION SOFT WHEN PROBED, LOW CROWN DENSITY, SMALL LEAVES
9	LIVE OAK	30									N	NOT A GRAND, TRI-DOMINANT, INCLUDED BARK, SMALL LEAVES, DIEBACK, LOW CROWN DENSITY, SURFACE ROOTS WITH WOUNDS FROM PREVIOUS MOWER DAMAGE, ROOTS BEGINNING TO DECAY
10	LIVE OAK	49	154	46	200	65	82	73.5	18.375	218.375	Y	THIS IS 2 TREES TOUCHING AT BASE, LOW CROWN DENSITY, SMALL LEAVES, DIEBACK

GRAND TREE EVALUATION	CONDITION
TREE # 5	
LIVE OAK 38" DIAMETER	NOT GRAND
TREE CONDITION EVALUATION	
ROOTS	B
TRUNK	D
LIMB/BRANCH STRUCTURE	B
TWIGS	B
FOLIAGE	B
HAZARD RATINGS	
FAILURE POTENTIAL	3
DEFECT SIZE	3
TARGET	1
Matheny/Clark Formula	7D

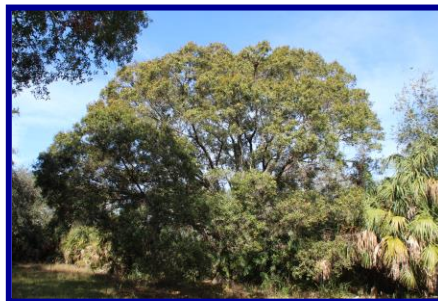
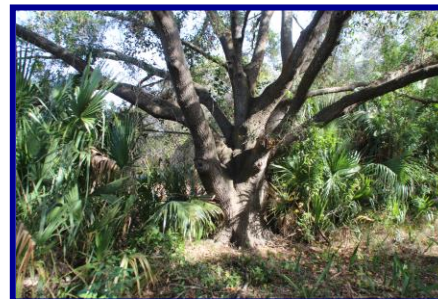
GRAND TREE EVALUATION	CONDITION
TREE # 6	
LAUREL OAK 37" DIAMETER	NOT GRAND
TREE CONDITION EVALUATION	
ROOTS	B
TRUNK	B
LIMB/BRANCH STRUCTURE	C
TWIGS	B
FOLIAGE	B
HAZARD RATINGS	
FAILURE POTENTIAL	2
DEFECT SIZE	2
TARGET	1
Matheny/Clark Formula	5C

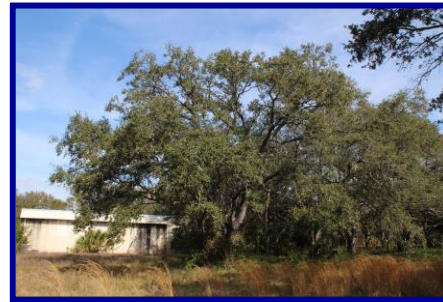
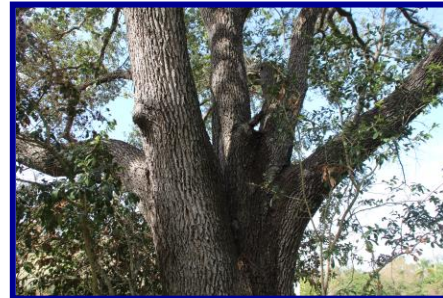
GRAND TREE EVALUATION	CONDITION
TREE # 8	
LIVE OAK 38" DIAMETER	NOT GRAND
TREE CONDITION EVALUATION	
ROOTS	B
TRUNK	D
LIMB/BRANCH STRUCTURE	B
TWIGS	B
FOLIAGE	B
HAZARD RATINGS	
FAILURE POTENTIAL	3
DEFECT SIZE	3
TARGET	1
Matheny/Clark Formula	7D

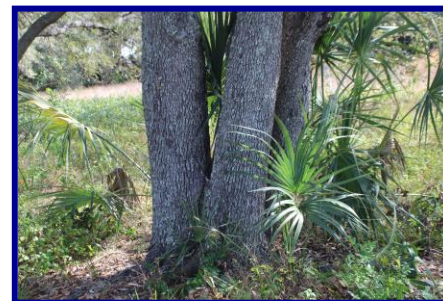
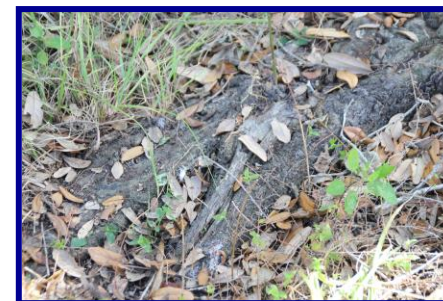
GRAND TREE EVALUATION	CONDITION
TREE # 9	
LIVE OAK 30" DIAMETER	NOT GRAND
TREE CONDITION EVALUATION	
ROOTS	B
TRUNK	D
LIMB/BRANCH STRUCTURE	B
TWIGS	C
FOLIAGE	C
HAZARD RATINGS	
FAILURE POTENTIAL	3
DEFECT SIZE	2
TARGET	1
Matheny/Clark Formula	6D
