LETTER OF TRANSMITTAL

GRAND TREE EVALUATION
CAREY FARMS/BRANDON HYATT
SEC. 20, TWP. 29S, RGE. 20E
FOLIO #s: 068100-0000; 068101-0000;
HILLSBOROUGH COUNTY, FLORIDA

February 29, 2008

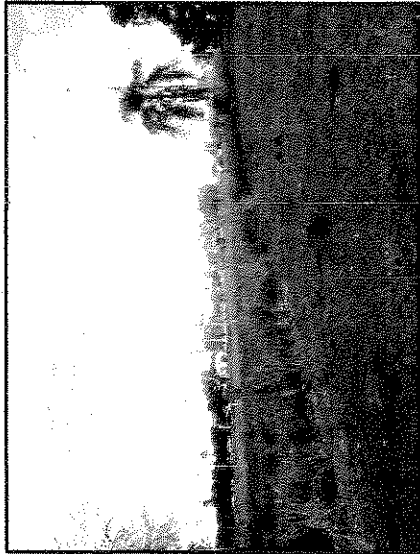
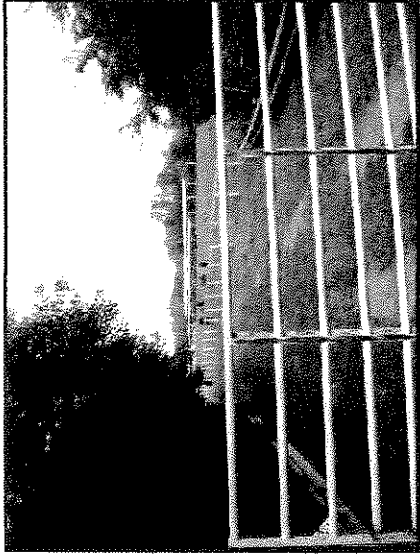
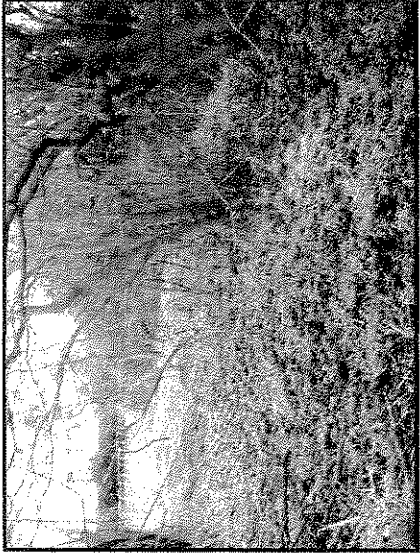
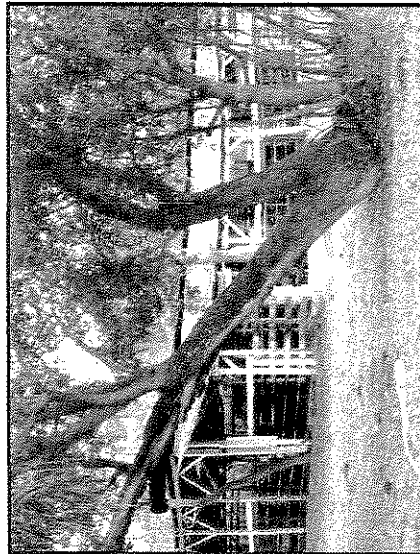
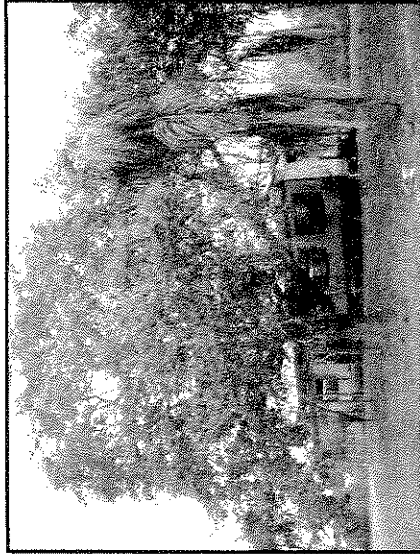
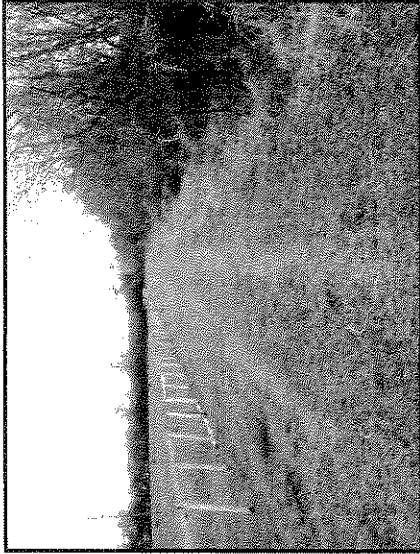
Figure 4.
Photographic Representation of Oak Trees On-Site

The property under the Florida Land Use Cover and Forms Classification System would be classified under # 191 Undeveloped land within urban areas, # 212 Unimproved pastures, # 231 Cattle feeding operations and # 6172 Mixed Shrubs (Figure 3). Large Live Oaks were located on site as shown in the photographs in Figure 4.

The two (2) surveyed and identified oaks were located, the dbh established and the trees were evaluated using the criteria listed on the Tree Condition Evaluation Form to assess the tree's condition. Tree's condition was determined from the sum of the condition points established from the rating of a tree's trunk circumference, height and average canopy. The condition ratings range from excellent to poor and are determined by a condition score system that weighs problems identified on each component of the tree. Each tree's location can be determined by referencing the number on the Grand Oak Evaluation Table, which corresponds to the identification number of each tree in Figure 5. The Tree Condition Evaluation Summary from the field reconnaissance are shown in Table 1. Two (2) Oak Trees (# 1 and # 2) by size can potentially be classified as GRAND, one (1) was not considered Grand Tree but is in a great condition and # 2 is too small to be considered a Grand Tree and it is a hazard.

TREE NUMBER 1 SCORE 168	TRUNK CIRCUMFERENCE 119.5 CONDITION score	HEIGHT OF TREE 32	TREE CANOPY NARROW 61 AVERAGE CANOPY CONDITION rank	WIDE 72 17 great	NOT A GRAND OAK
TREE NUMBER 2 SCORE 159	TRUNK CIRCUMFERENCE 125 CONDITION score	HEIGHT OF TREE 22	TREE CANOPY NARROW 35 AVERAGE CANOPY CONDITION rank	WIDE 58 12 poor	MEASURED WRONG tree measured at point of old failure see pictures SIZE TO SMALL HAZARD
