**PHASE I  
ENVIRONMENTAL SITE ASSESSMENT**

**Vacant Pasture Land  
Parcel ID #'s 30-26-18-0000-00200-0010, 30-26-18-0000-00200-00W0  
Land O' Lakes  
Pasco County, Florida  
RETECHS Project # MINN09-13550-WBC-A.1**

**October 28, 2009**

**EAC Project Number: P09-1019**

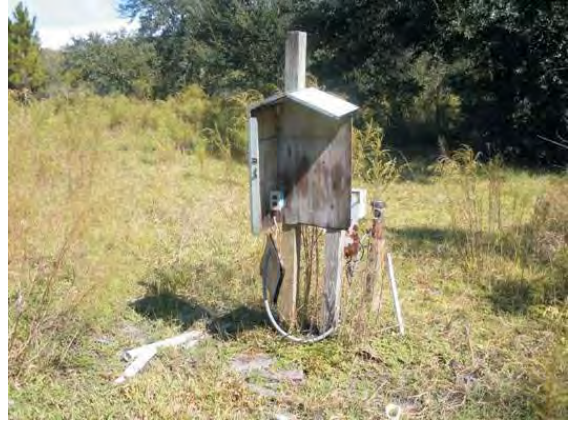
View of the an old power junction box

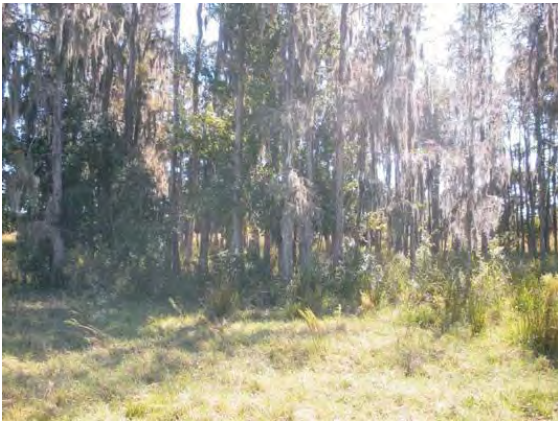
A low lying depressional area is centrally located on the subject site. In addition, there are no impoundments or other land uses known to be in existence at the site. One (1) small debris pile consisting of plastic plant pots was observed on the property.

View of a depressional area on the subject site

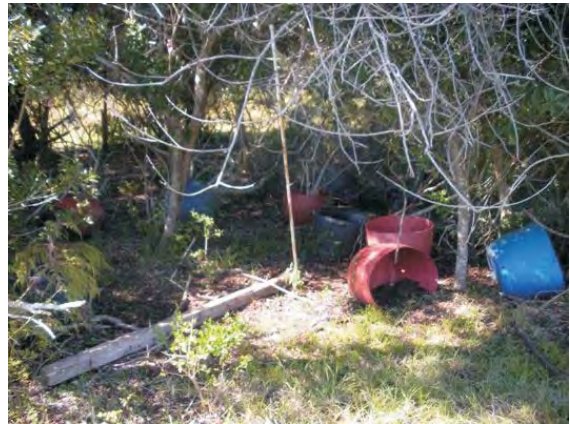
View of the on-site debris (tree pots)
