**ENVIRONMENTAL SITE ASSESSMENT  
FOR  
"2,216 ACRE PROPERTY,  
SOUTH OF BUCKEYE ROAD,  
WEST OF U.S. HIGHWAY 301,  
PARRISH,  
MANATEE COUNTY, FLORIDA"**

November 9, 2005  
File No. 05-8850

SUBJECT: Environmental Site Assessment for "2,216 Acre Property, South of Buckeye Road,  
West of U.S. Highway 301, Parrish, Manatee County, Florida"

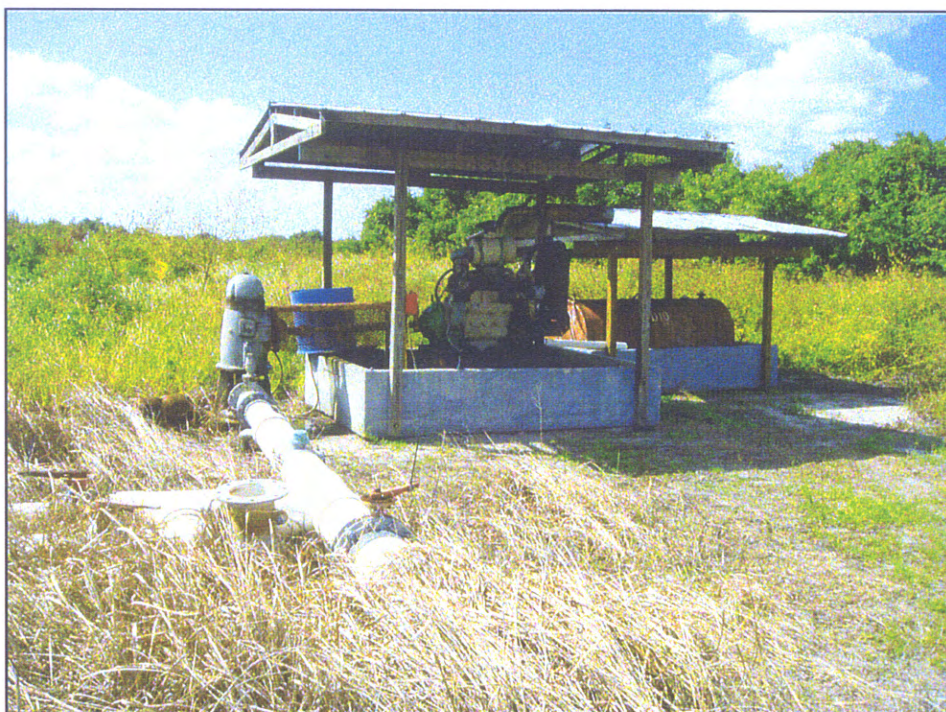
For purposes of this assessments, areas of note will be discussed by number as shown in Figure 3. At location 1 on the subject property, a production well and above ground storage tank was identified. Both the diesel pump and diesel tank were located within secondary containment units. Some accumulated rainwater was observed within the containment units which are covered and some chemical and oil containers were noted. An obvious oil sheen was noted on the surface of the water, however, no stainage of the surrounding soils was noted. A sump pump which appears

Location #1 – wellhead and tank

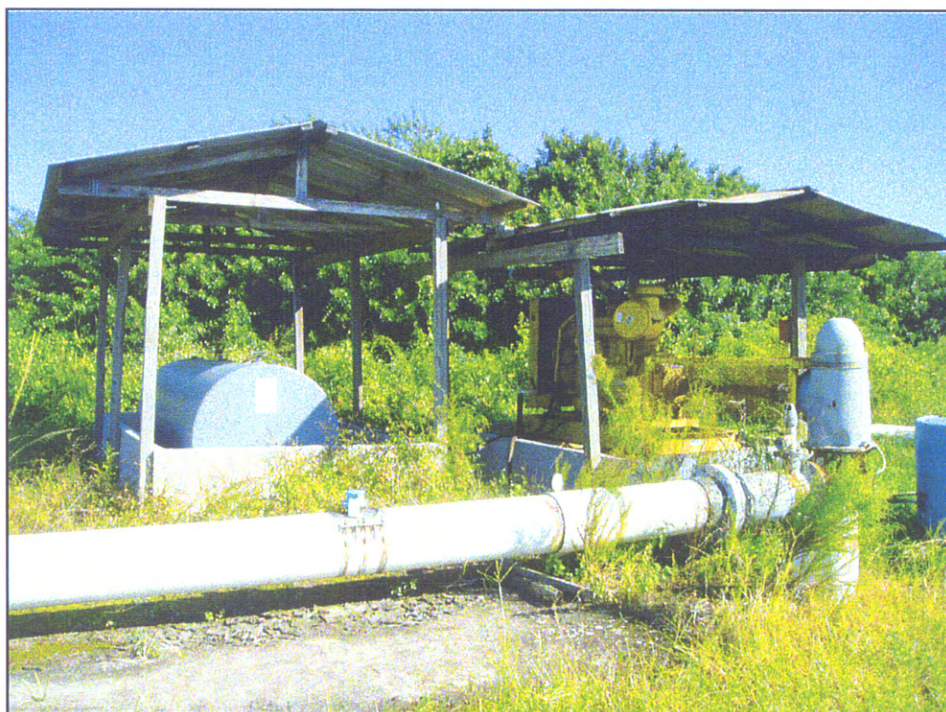
Location #2 – wellhead, tank and hose bib

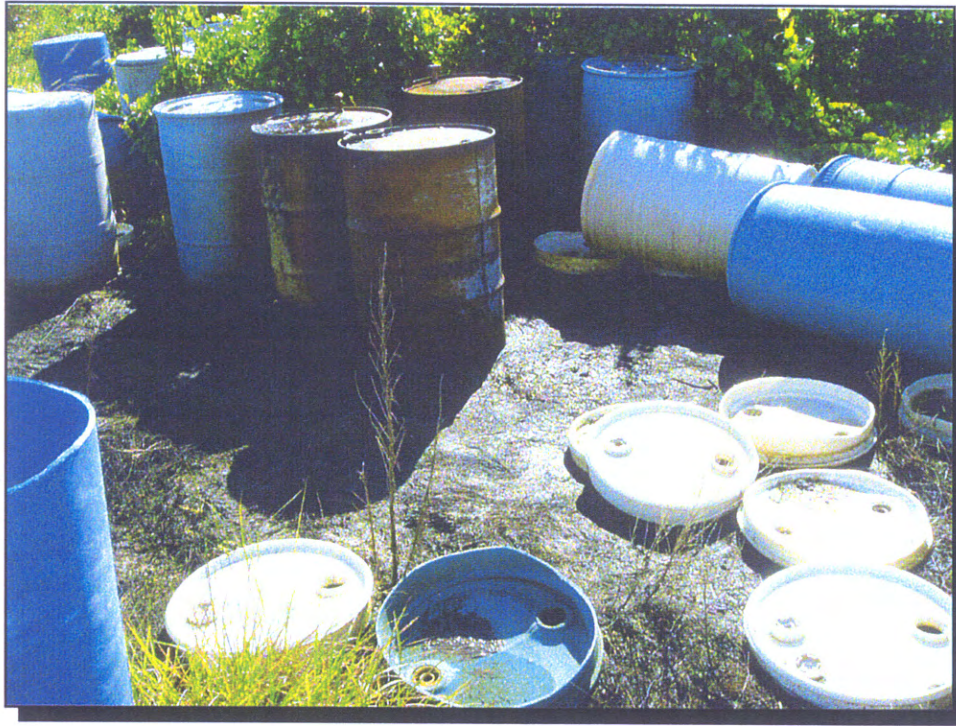
Location 3, located in the south boundary of Section 08, is an area which is referred to by Mr. Widdon as the junkyard. Items identified in the area include a number of farm implements, derelict trucks, a mobile diesel fuel tank, empty and partially full 55-gallon drums (content unknown) and a large area of oil stainage on the ground around a number of waste oil drums. It appears that the drums have overflowed onto the ground surface and the oil has been transported by standing water which has since settled and killed the vegetation in the area. This area was called to the attention of Mr. Widdon during a subsequent telephone conversation.

advised of the large area of waste oil impact in the junk yard location. Mr. Widdon indicated that most solid waste on the site is disposed in roll off dumpsters which are serviced by Waste Management. However, some wooden boxes are burned on the property. All waste oil generated on-site along with oil filters is transported from the site on an as-needed basis by a licensed waste hauler. Major repairs to the farming equipment does not occur on the property, but at a nearby Pacific Tomato Farm # 1.

Location #3 – junkyard area where derelict equipment, several drums, and heavy soil stains were noted

- The potential for the presence of Arsenic in surficial soils in well head locations or at random locations throughout the agricultural fields as well as at the burn pile.
- The potential for petroleum impacts at all existing tanks and at Location No. 3, No. 6, No. 10 and No. 12.
- The potential for accumulation of agricultural chemicals in the soils at Location No. 4 and No. 9 as a result of continued use of these well heads and mixing areas.
- The potential for accumulation of chlorinated pesticides in the soils at the former cattle pen at Location No. 8.

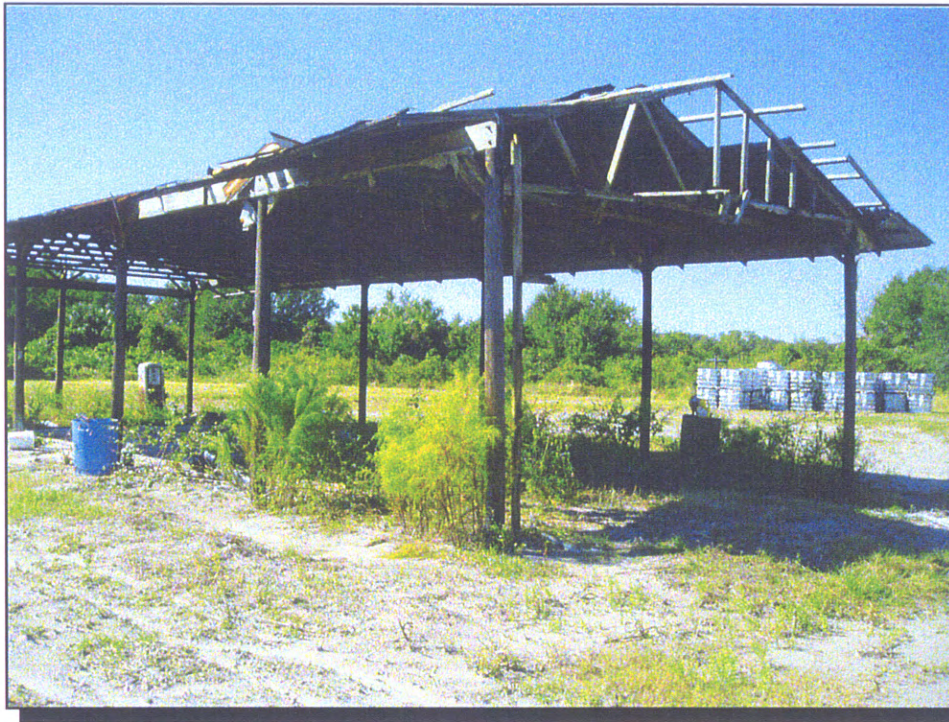
Location No. 7 is a former maintenance area which includes a pole barn over a concrete slab. On the date of site reconnaissance, only one (1) tractor and some rolls of sheet plastic were located in the area. Otherwise the former maintenance area was abandoned of equipment or supplies. Some remnants of the former operations were noted which included a fuel pump and a 55-gallon drum of assorted parts and garbage. No stainage of the soils was identified at the perimeter of the slab.

Location #7 – former equipment maintenance area

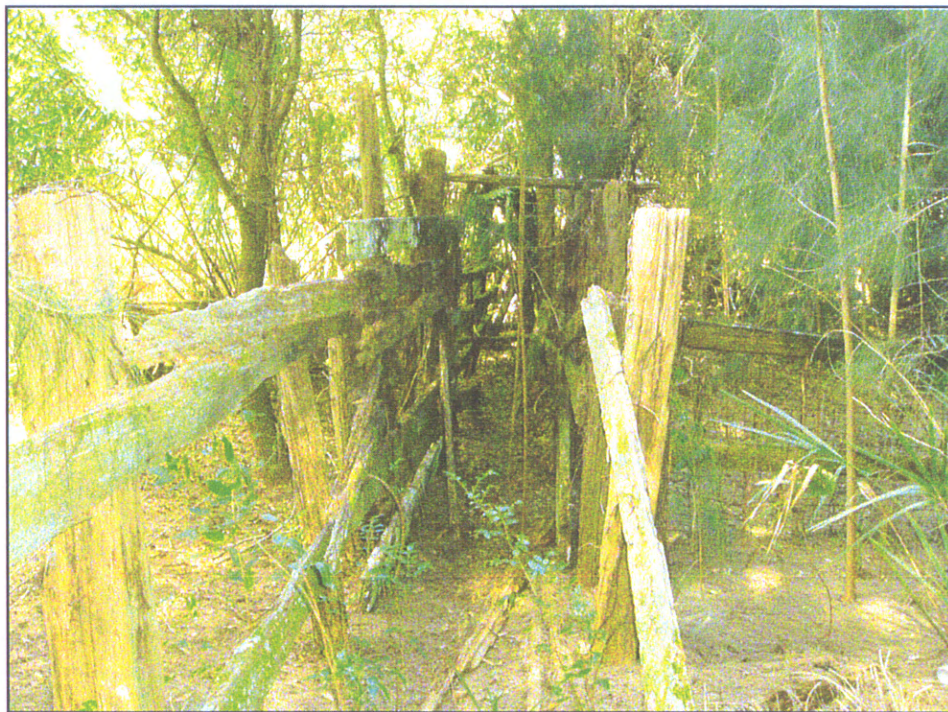
- Two (2) cattle pen locations were identified on the site. While one is a recent addition to the property and is not assumed to be of significant concern, a cattle pen was located at the south central portion of the site for a number of years. A treatment chute is present in the area. The potential exists for accumulation of pesticides in the soils as result of application to cattle in this area.

Location #8 – former cattle pen, chute and loading ramp

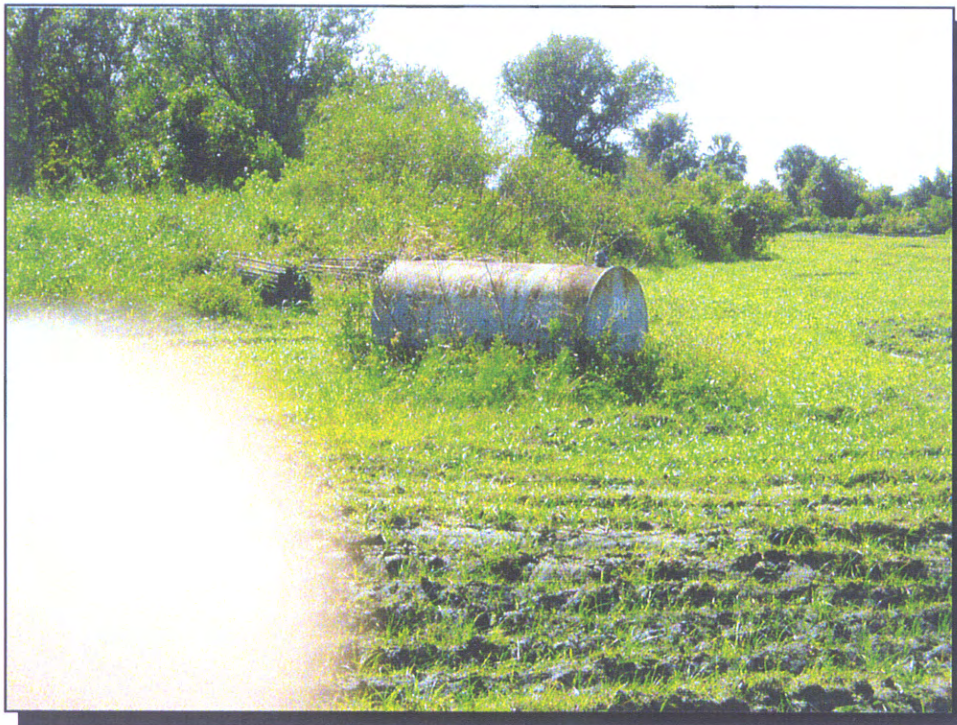
Location No. 10 is within a currently fallow field at which point a petroleum storage tank is located. No stains were identified in proximity to the tank. The tank, however, is not within a secondary containment unit. It does not appear that the tank has been utilized for quite some time.

Location #10 – skid tank abandoned in southwest corner of Section 07

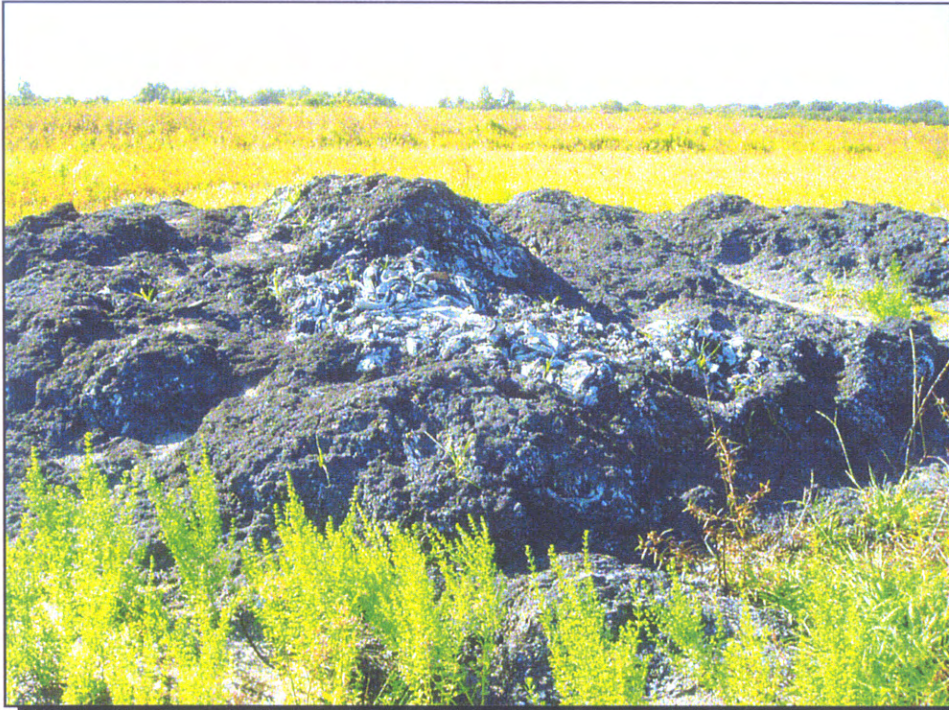
Location No. 11 is the location of a burn pile on the subject property which appears to be a significant burn area with accumulation of a significant amount of ash. It appears that plastic is

burned at this location due to the texture of the residue. No vehicle parts or fuel filters were identified within the ash pile. The potential does exist for accumulation of metals in the soils at these locations as a result of the burn residue. For the most part, smaller burn areas were identified throughout the field which is an accepted best management practice on the property. Mr. Widdon indicated that plastics are typically not burned on the property, but are disposed in roll off dumpsters. He indicated that the material typically burned on the property included cardboard and paper bags.

Location #11 – burn pile with plastic/ash residue

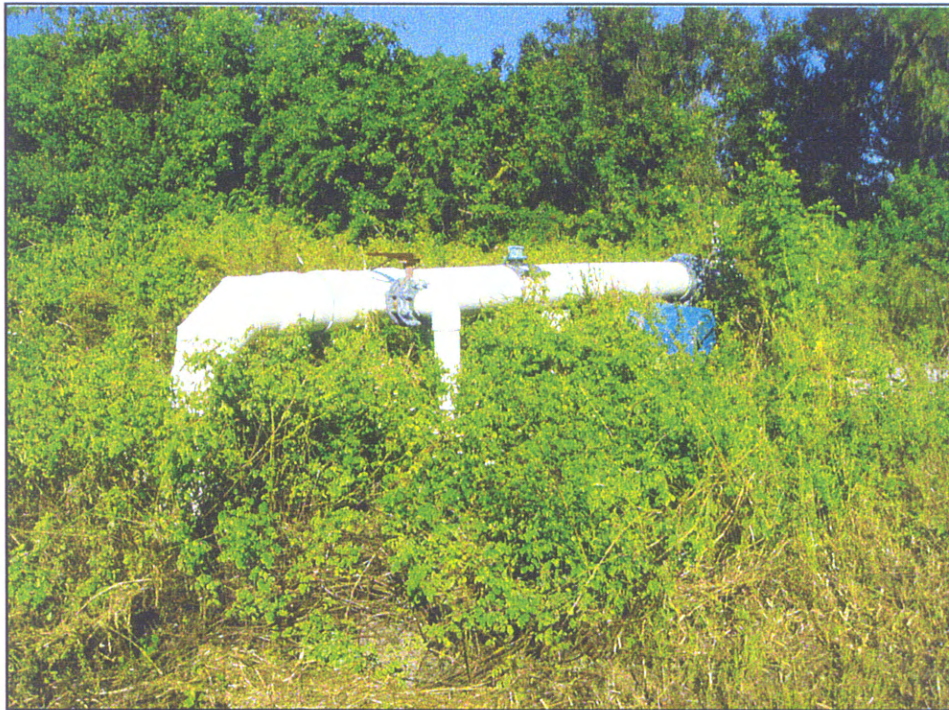
Location #12 – former wellhead location where substantial petroleum impacts to soil were previously identified
