PHASE I ENVIRONMENTAL SITE ASSESSMENT

PHASE I ESA - SITE PLAN
TAMPA HOUSING AUTHORITY
 1000 INDIA STREET
 TAMPA, FLORIDA

Central Park Village
 1000 India Street
 Tampa, Florida

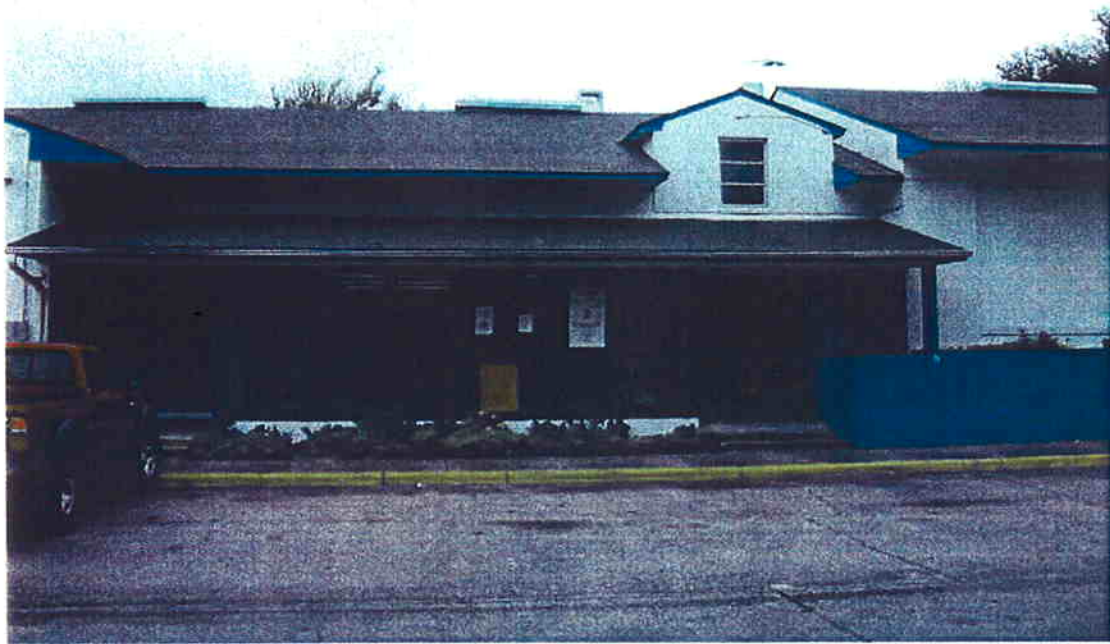
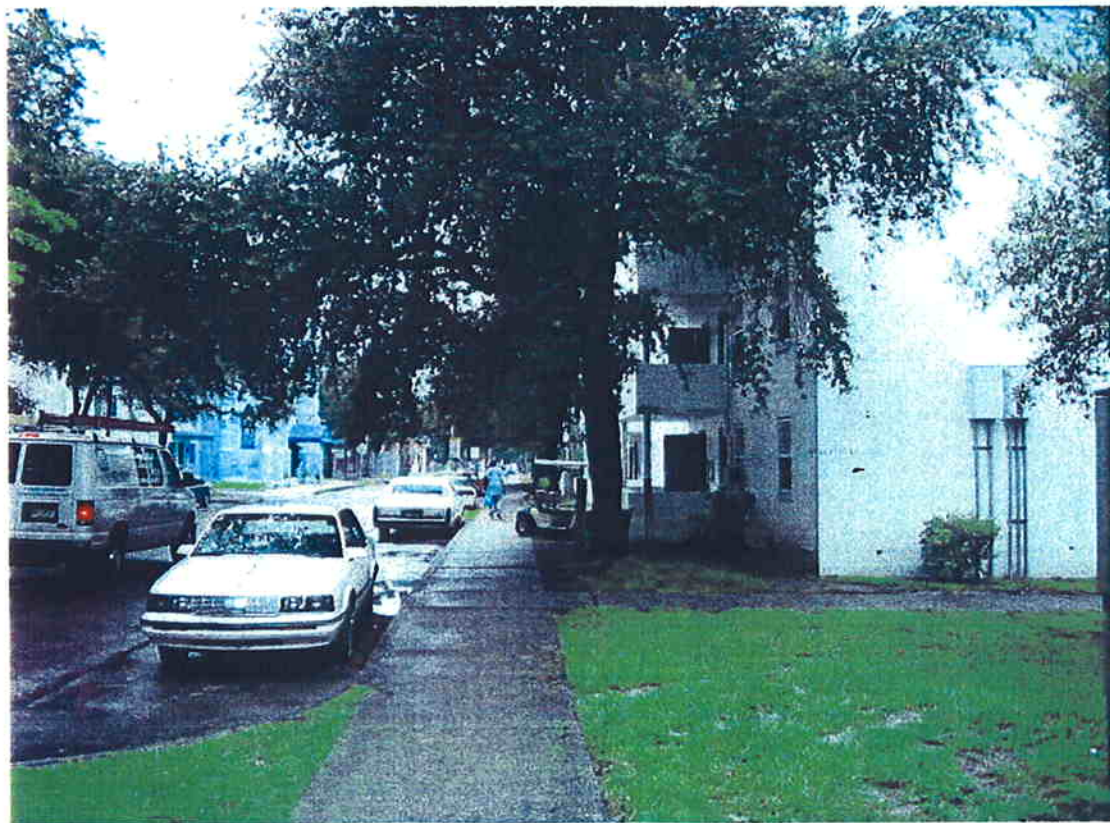
Photo B-1

Upper Photo: View of the subject site front office.
 Lower Photo: View of the northern property boundary facing east.

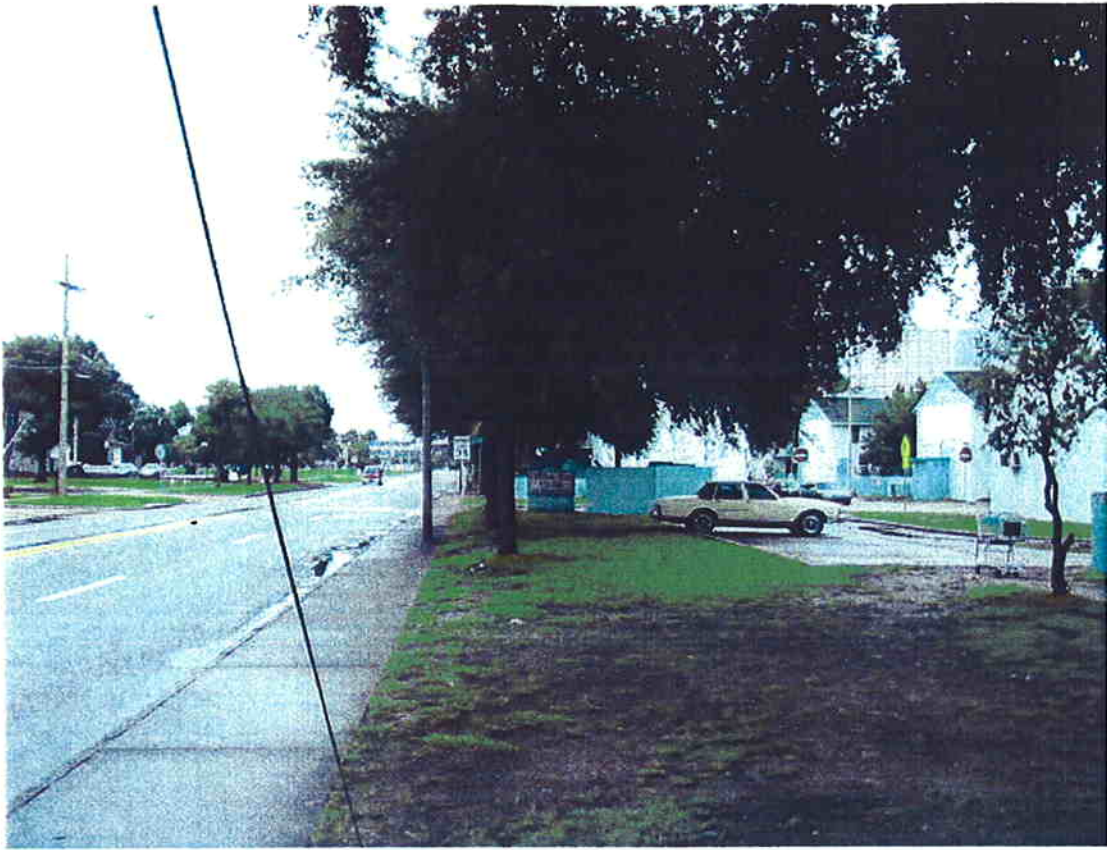
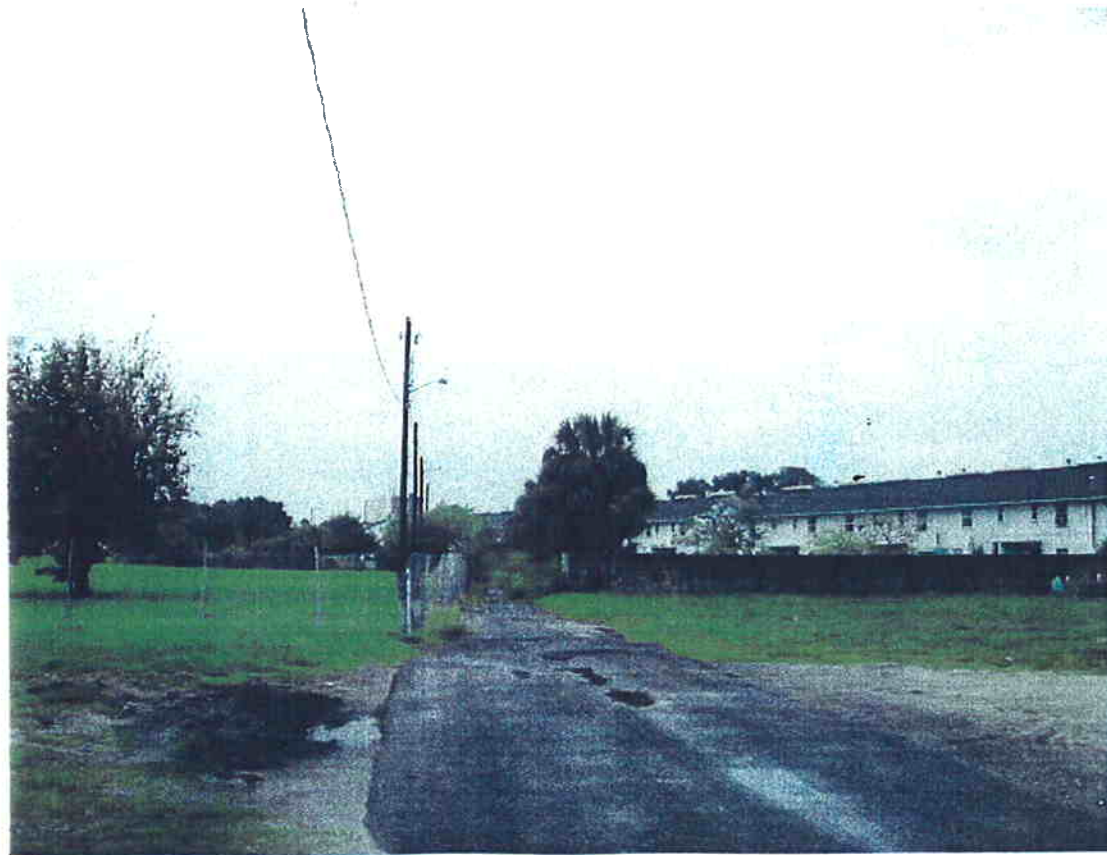
Photo B-2

Upper Photo: View of the eastern property boundary facing south.
 Lower Photo: View of southern property boundary facing west.

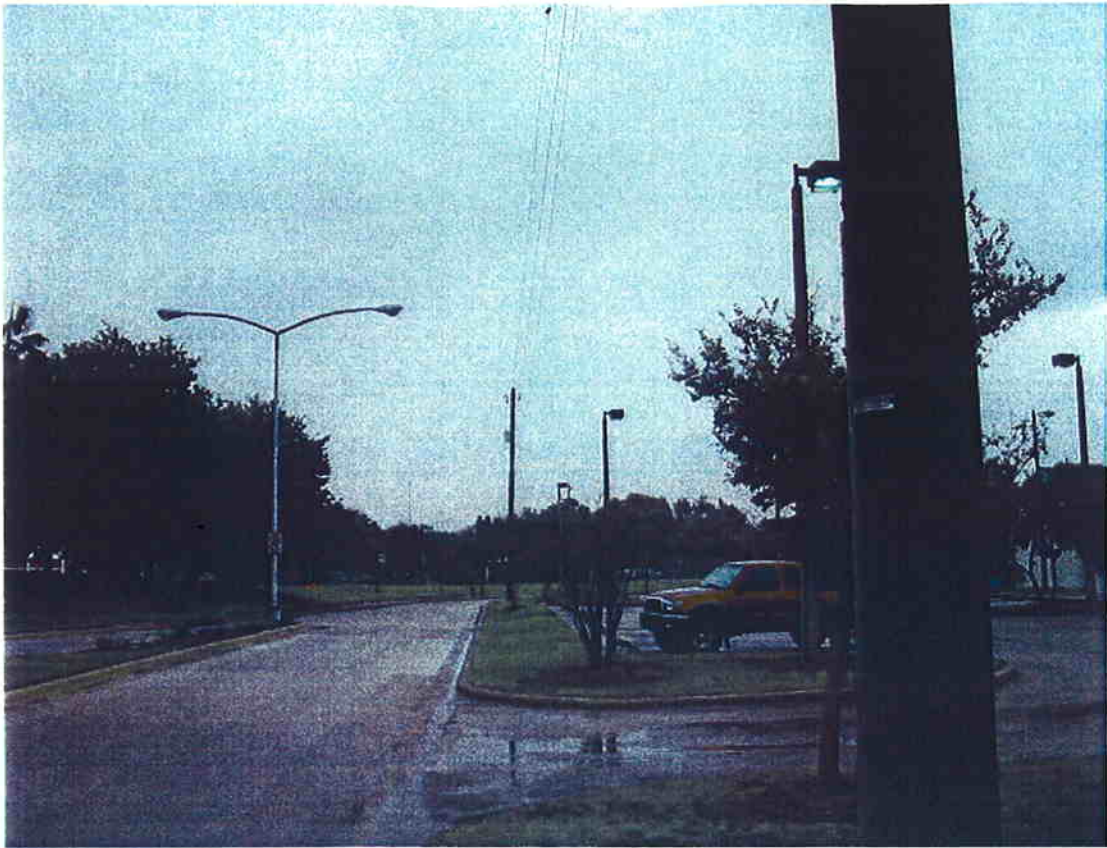
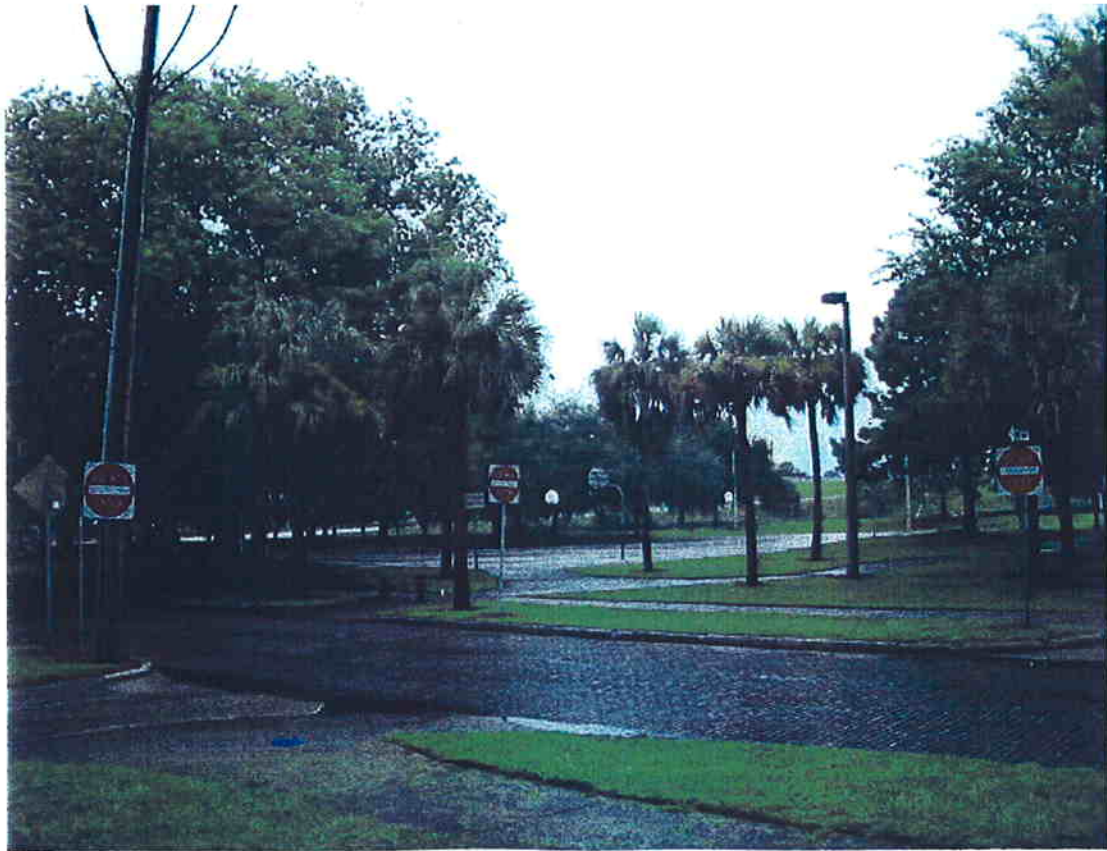
Photo B-3

Upper Photo: View of the western property boundary facing north.
 Lower Photo: View of western adjoining park across North Orange Avenue.

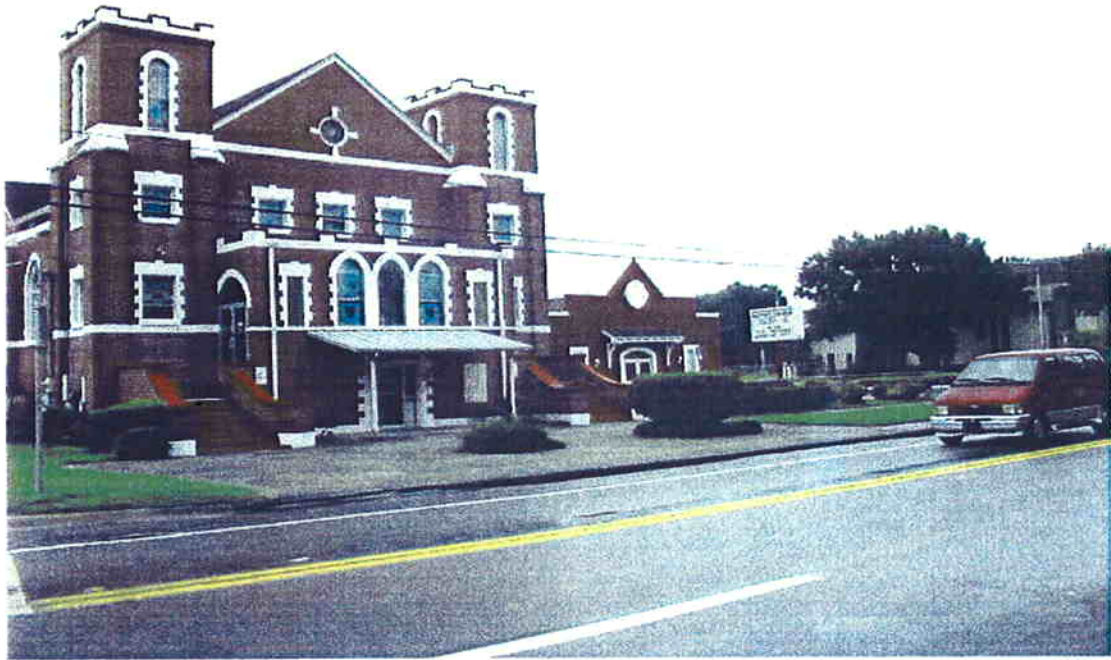
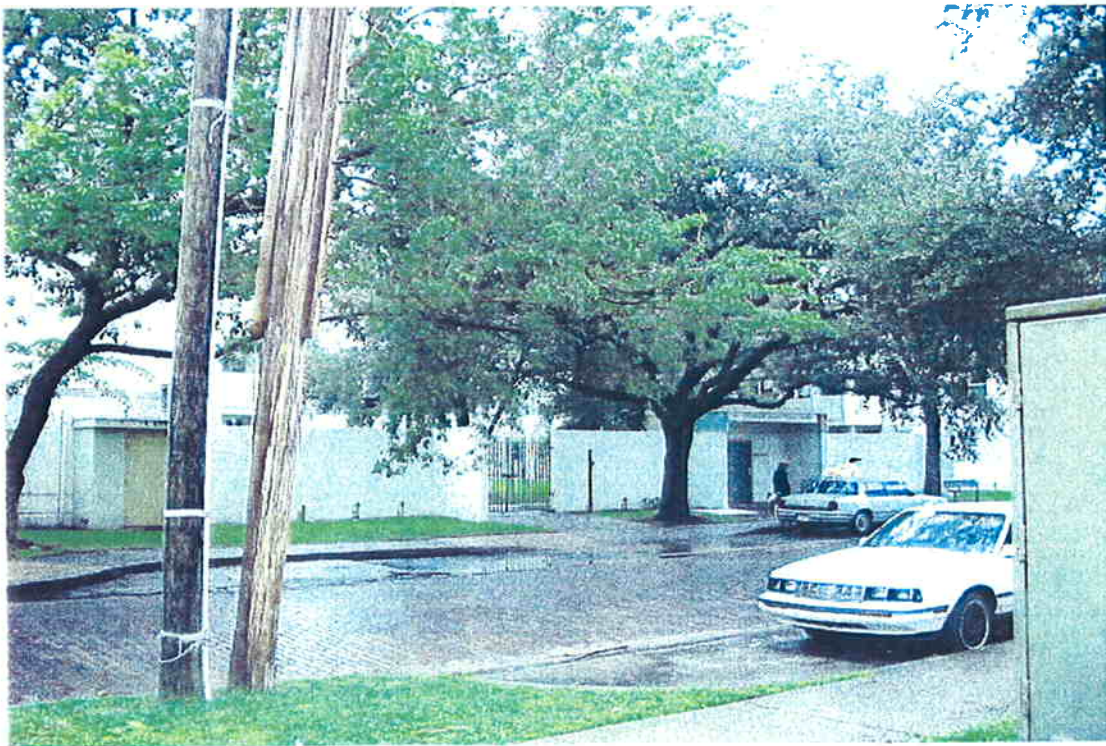
Photo B-4

Upper Photo: View of eastern adjoining church across North Nebraska Avenue.

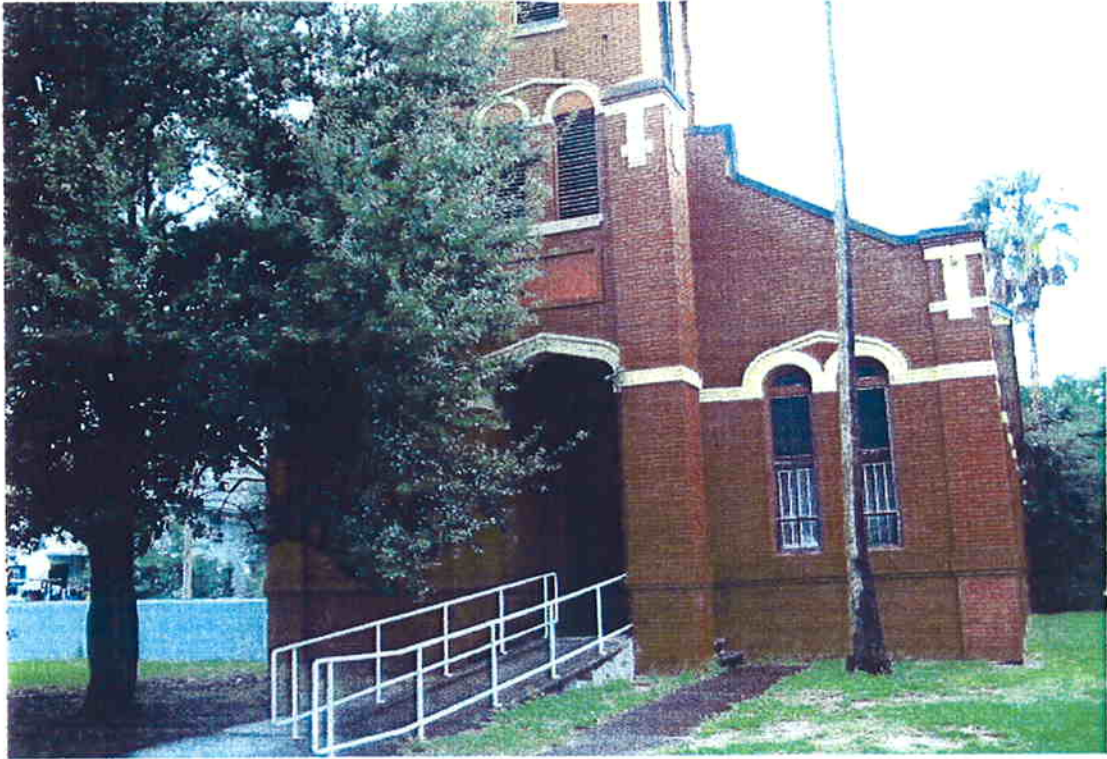
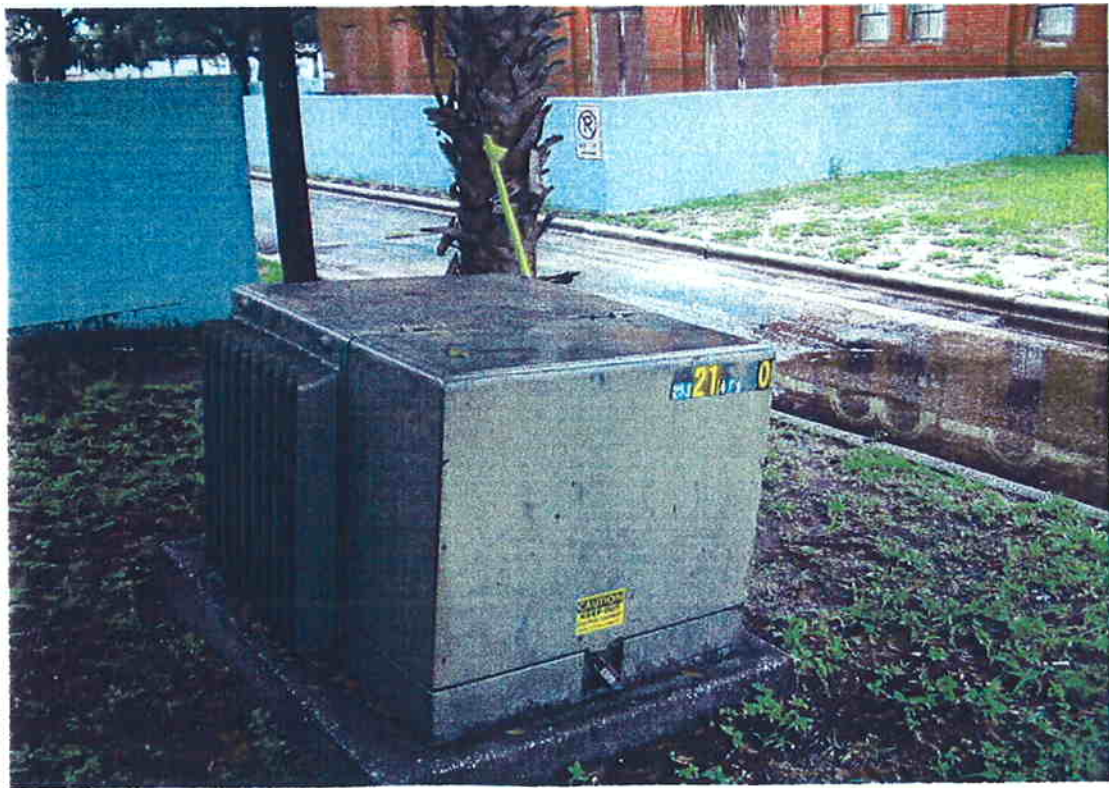
Photo B-5

Upper Photo: View of church on the subject site.
 Lower Photo: View of typical pad-mounted transformer on the subject site.
