REMEDIAL ACTION PLAN
Countryside Executive Golf Course
2506 Countryside Blvd.
Clearwater, Florida
HSA Project Number 601-5982
June 2010

**REMEDIAL ACTION PLAN
Countryside Executive Golf Course
2506 Countryside Boulevard
Clearwater, Pinellas County, Florida**

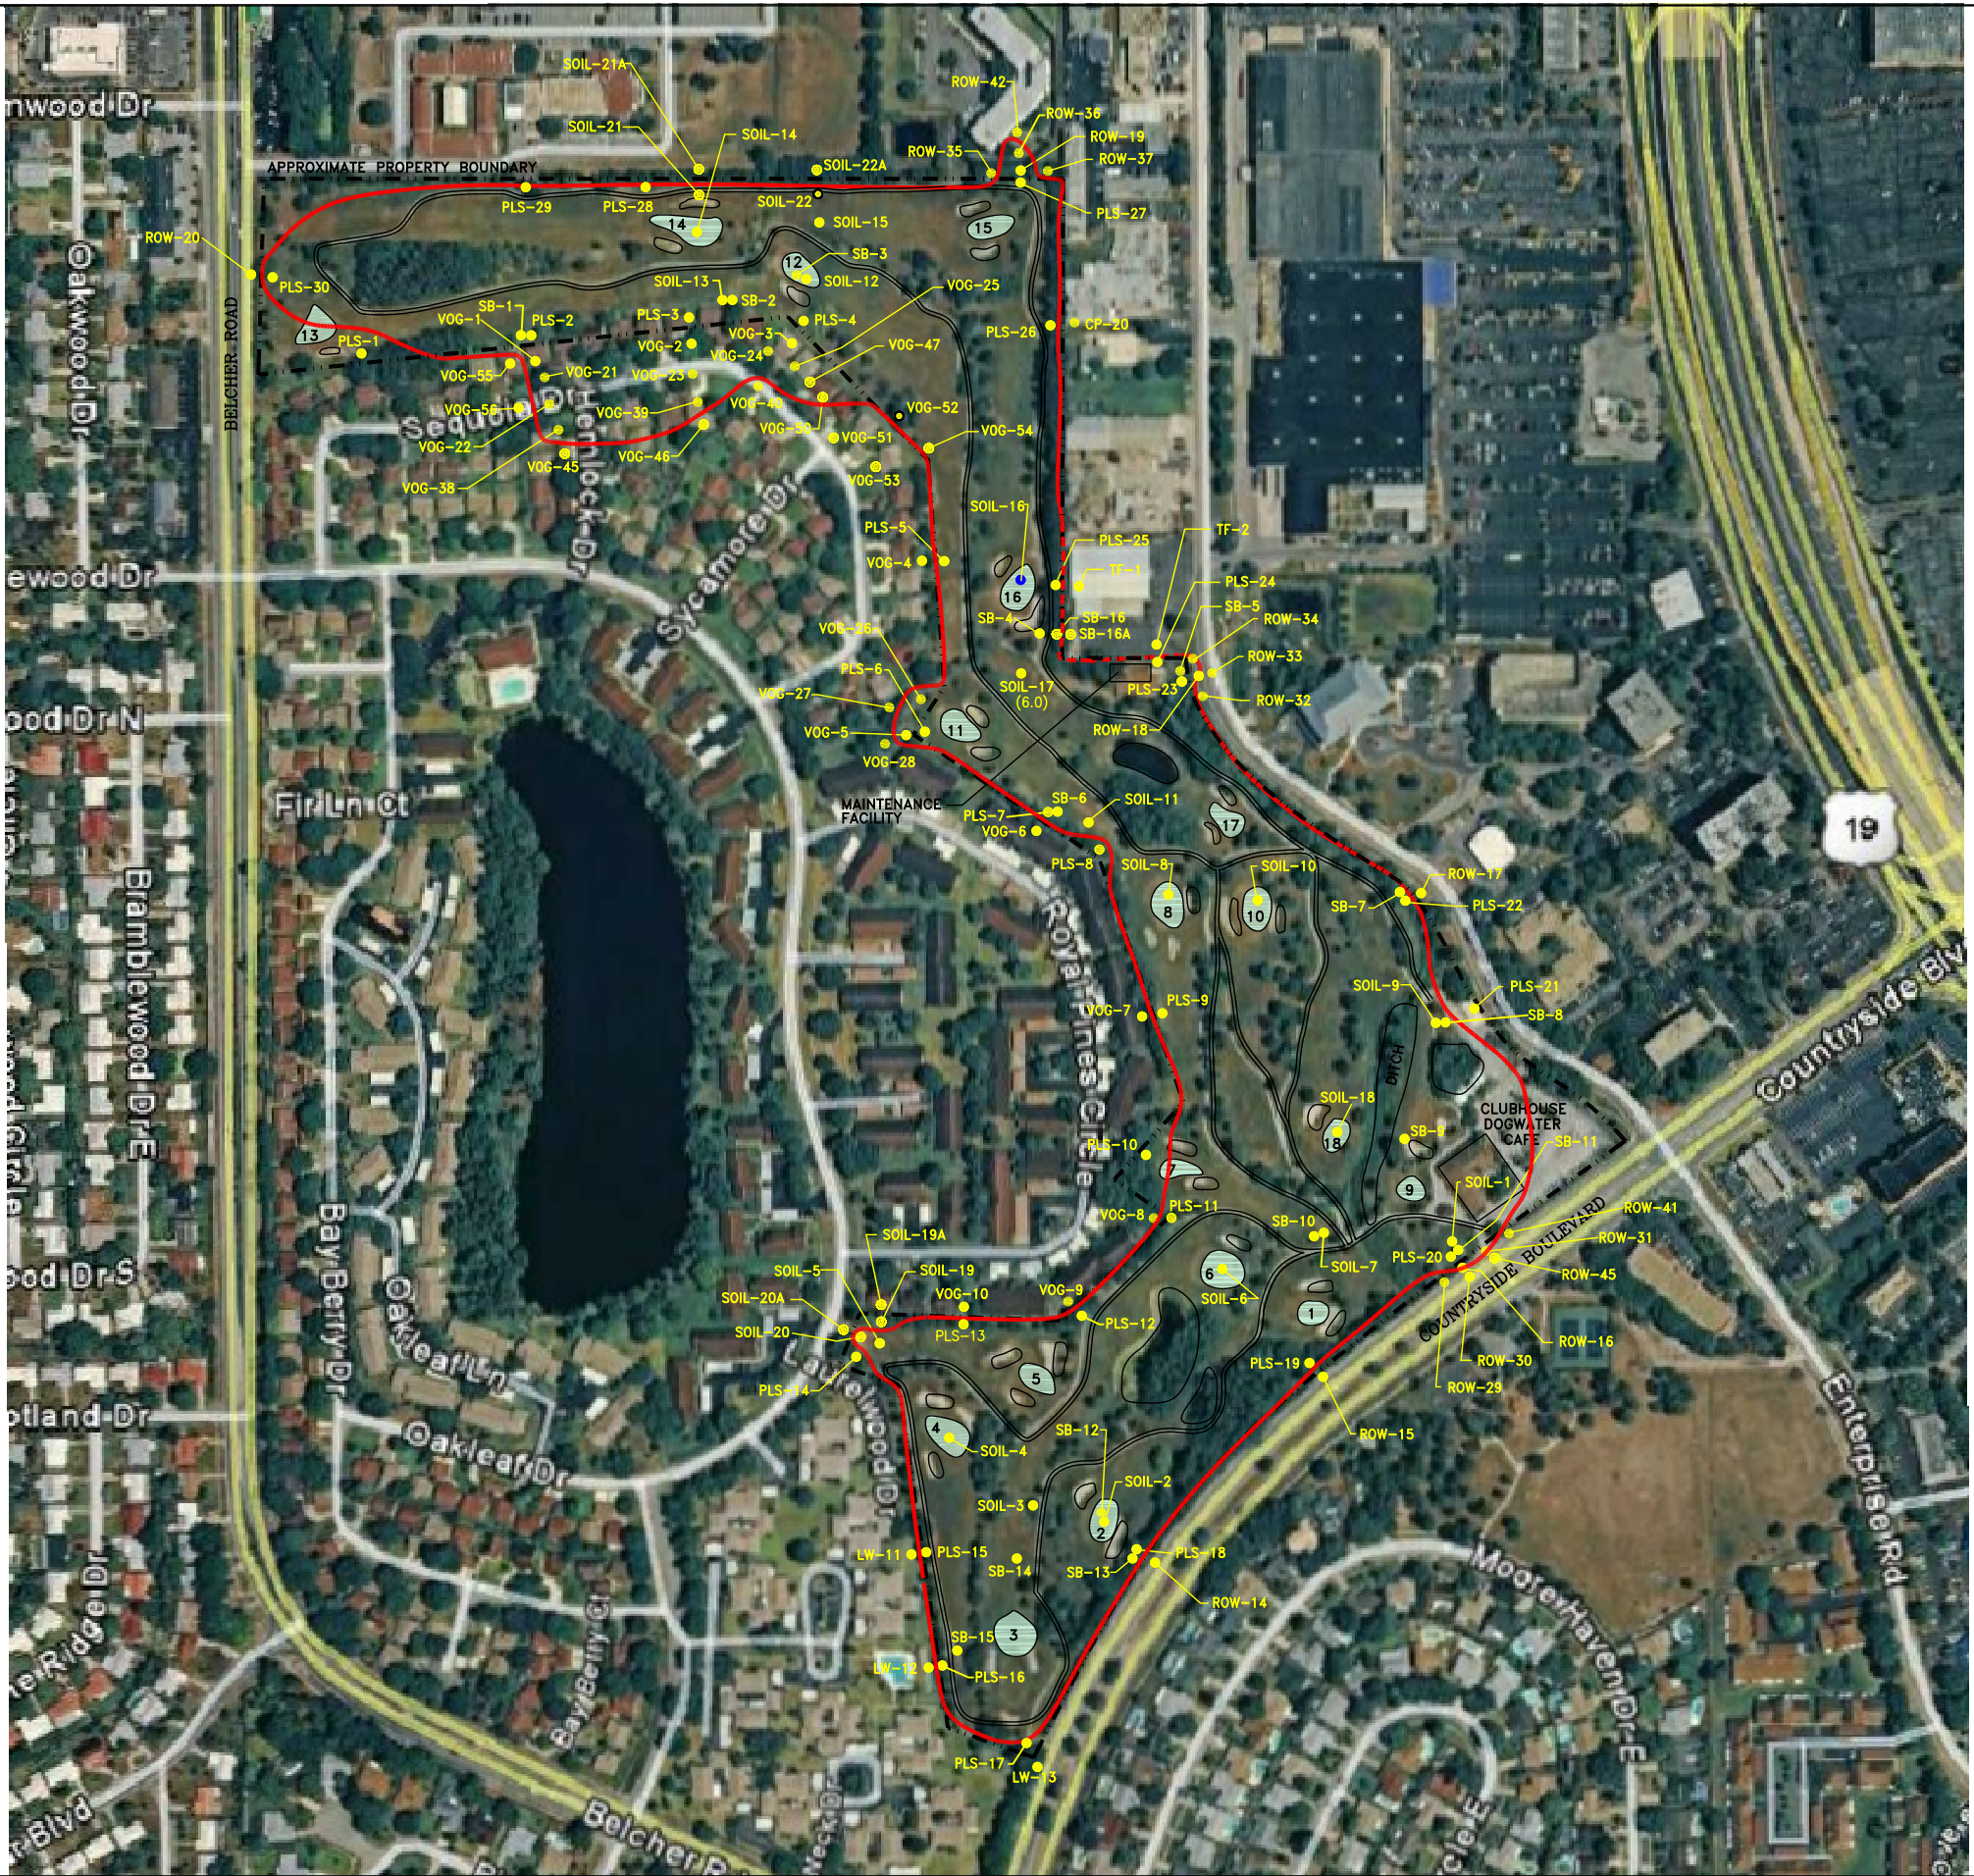
- SOIL SAMPLE LOCATION (2009)—DESIGNATIONS VARY (SHOWN IN YELLOW)
- SB-1 ● PREVIOUS SOIL SAMPLE LOCATIONS—DESIGNATIONS VARY (SHOWN IN YELLOW)
- ARSENIC CONTOUR FOR VALUES WHICH EXCEED THE RESIDENTIAL SCTL OF 2.1 mg/kg, DASHED WHERE INFERRED

SHEET TITLE
EXTENT OF ARSENIC IMPACTS
