INTERIM SOURCE REMOVAL PLAN AND  
GROUNDWATER MONITORING PLAN  
Countryside Executive Golf Course  
2506 Countryside Boulevard  
Clearwater, Pinellas County, Florida  
July 2006

**HSA Engineers & Scientists**  
4019 East Fowler Ave.  
Tampa, Florida 33617  
HSA Project Manager: Brian Moore, P.E.  
*HSA Project No. 6016036*

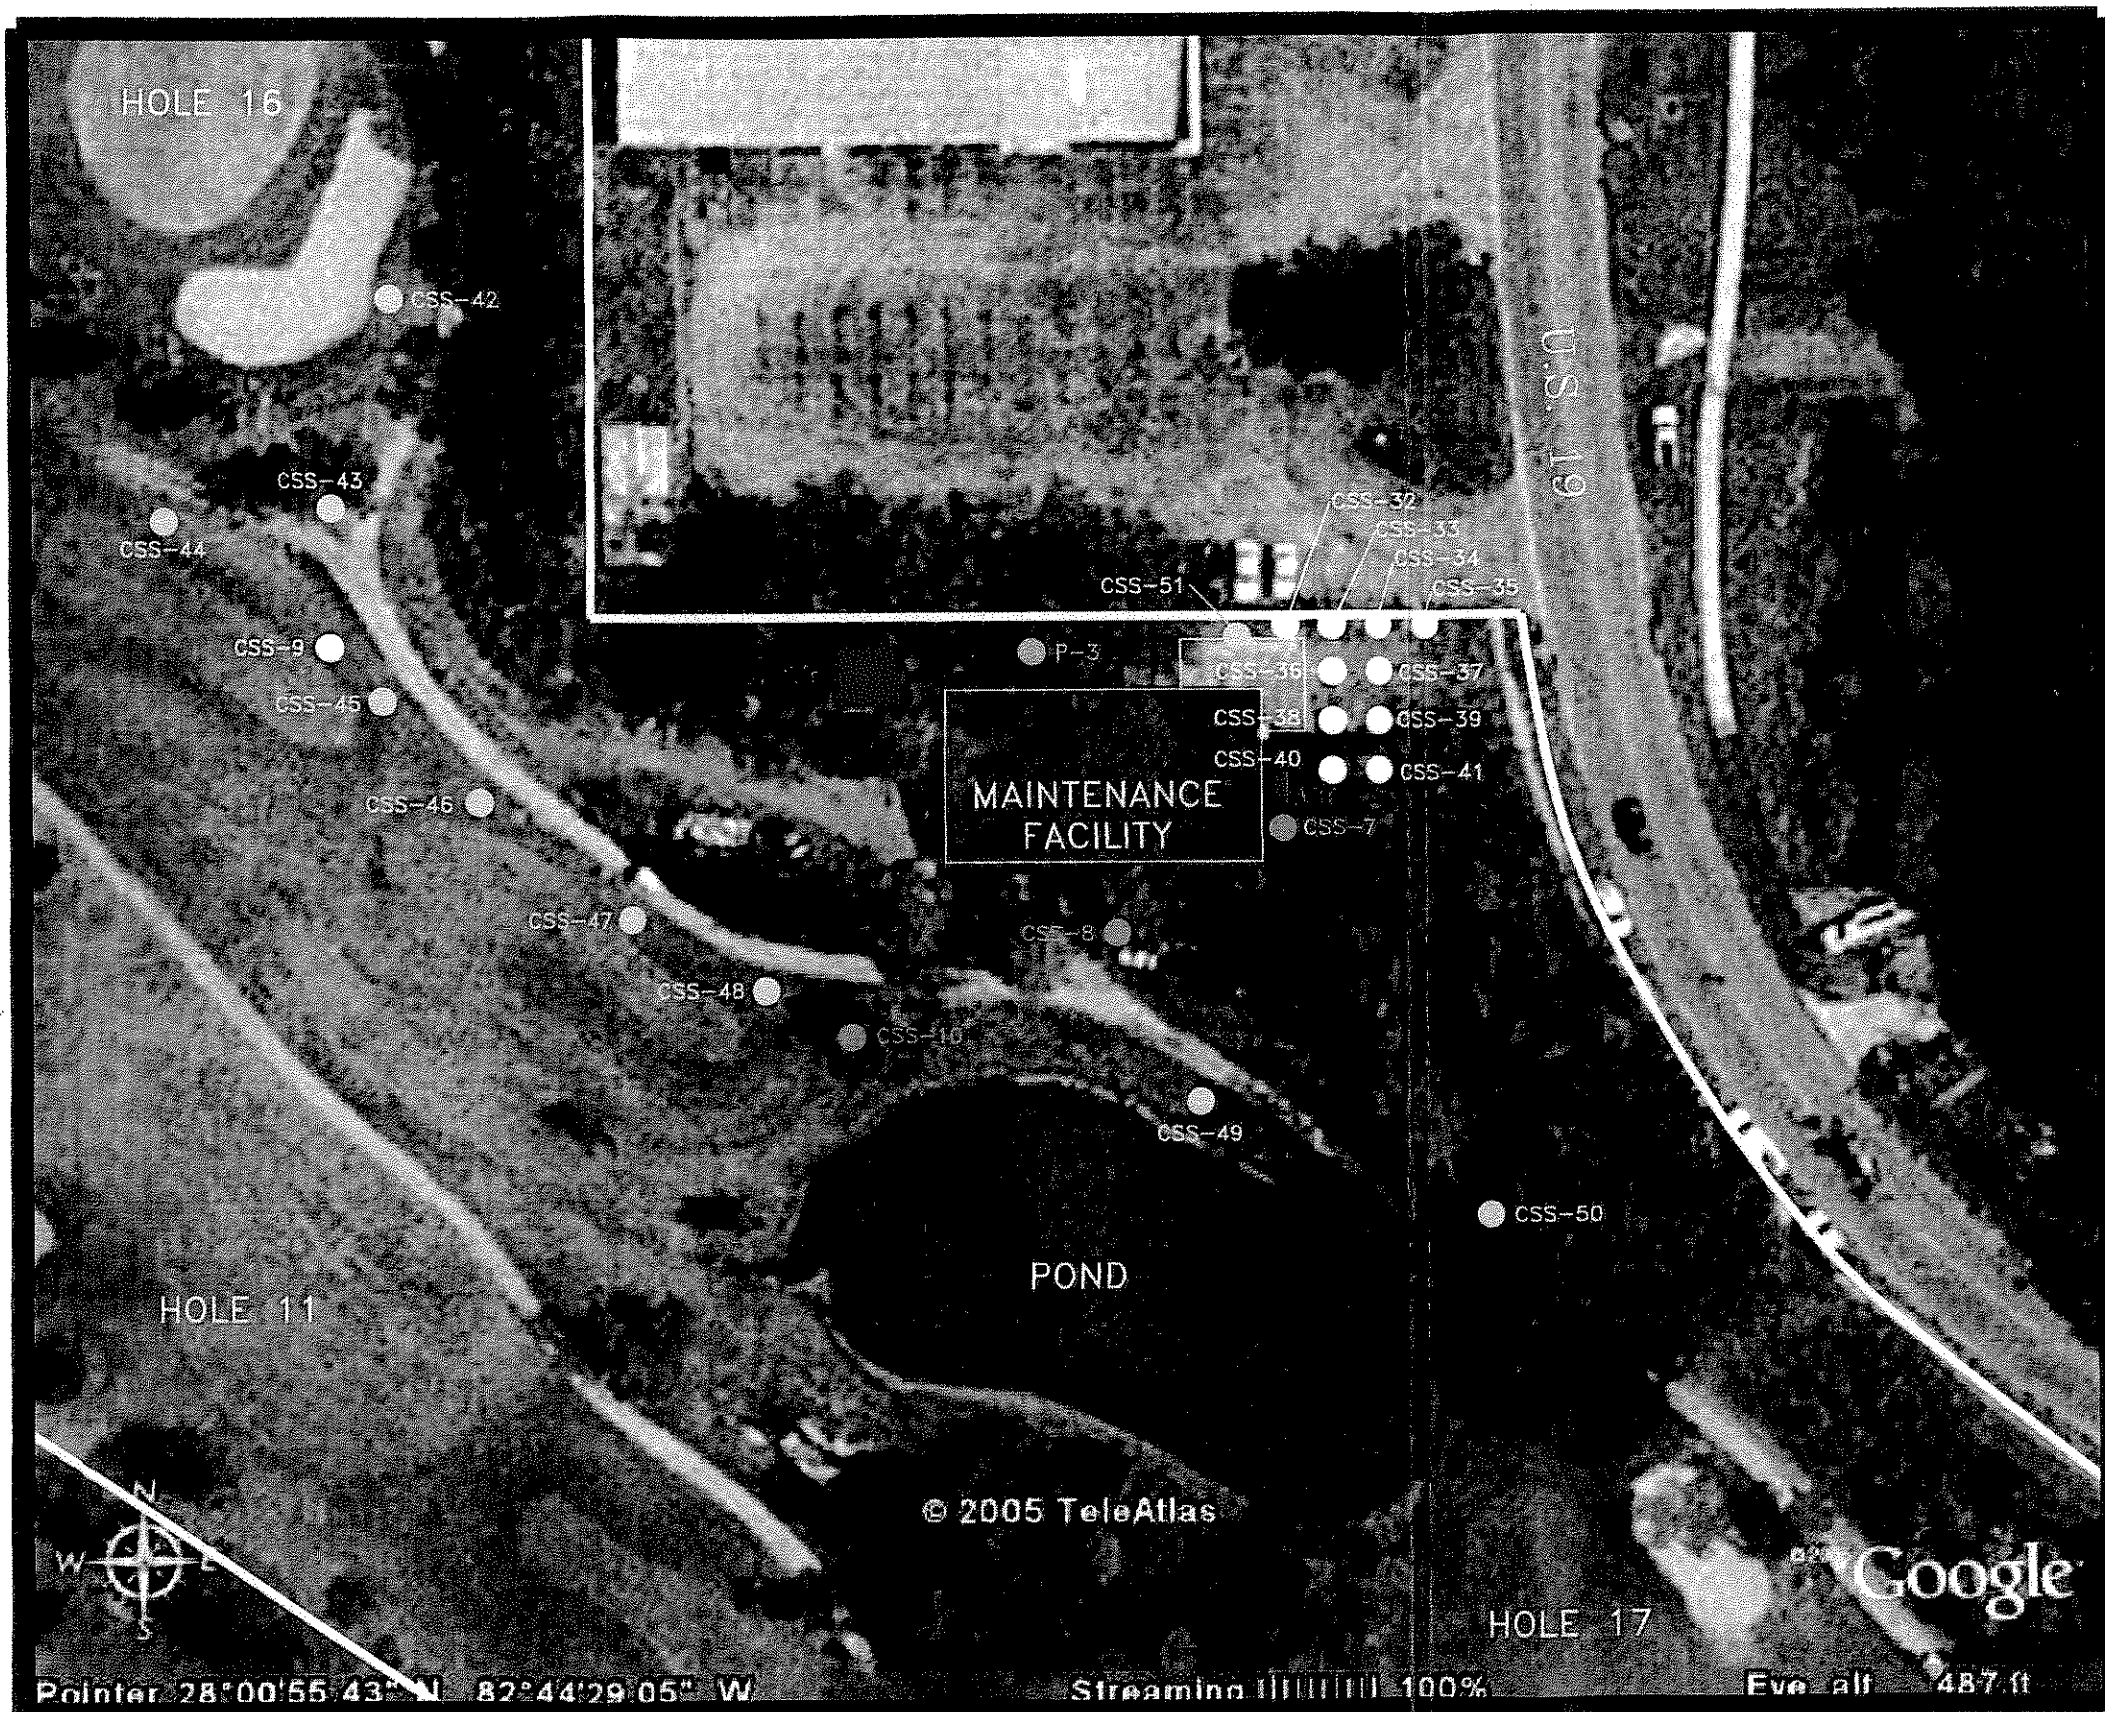
DESIGNED	N/A	JOB NO.:	601589200
DRAWN	SBW	DATE:	7/5/06
CHECKED	BM	CAD NO.:	589200-02
SHEET TITLE SOIL SAMPLING LOCATION PLAN (MAINTENANCE FACILITY)			
FIGURE 2

- AST ■ ABOVEGROUND STORAGE TANK LOCATION
- SOIL SAMPLE LOCATIONS (CSS-11-CSS-41) TAKEN OCTOBER 1-7, 2004
- SOIL SAMPLE LOCATIONS (P-1-P-6) TAKEN OCTOBER 1-7, 2004
- SOIL SAMPLE LOCATIONS (CSS-42-CSS-50) TAKEN NOVEMBER 15-16, 2004
- SOIL SAMPLE LOCATIONS (CSS-1-CSS-10) TAKEN AUGUST 26, 2004

In general, arsenic soil impacts above default Residential Exposure Soil Cleanup Target Levels (SCTLs) found in Chapter 62-777, FAC were detected throughout the subject site in shallow soils and an area of groundwater arsenic impacts above Groundwater Cleanup Target Levels (GCTLs) found in Chapter 62-777, FAC were identified in the immediate vicinity of the maintenance facility. A summary of historical soil sampling arsenic analytical results for the immediate vicinity of the maintenance facility is included as **Table 1**. A soil sampling location plan (maintenance facility) is included as **Figure 2**. The results of the soil analysis indicate arsenic concentrations varying from below laboratory reporting levels to 48 milligrams per kilogram (mg/kg). The highest concentrations of arsenic were detected in shallow soils (top six inches) at locations CSS-33 (48 mg/kg) and CSS-40 (13 mg/kg), which are located east of the maintenance facility. The concentrations of arsenic in soil generally decrease with depth and to the south and west of the maintenance facility.

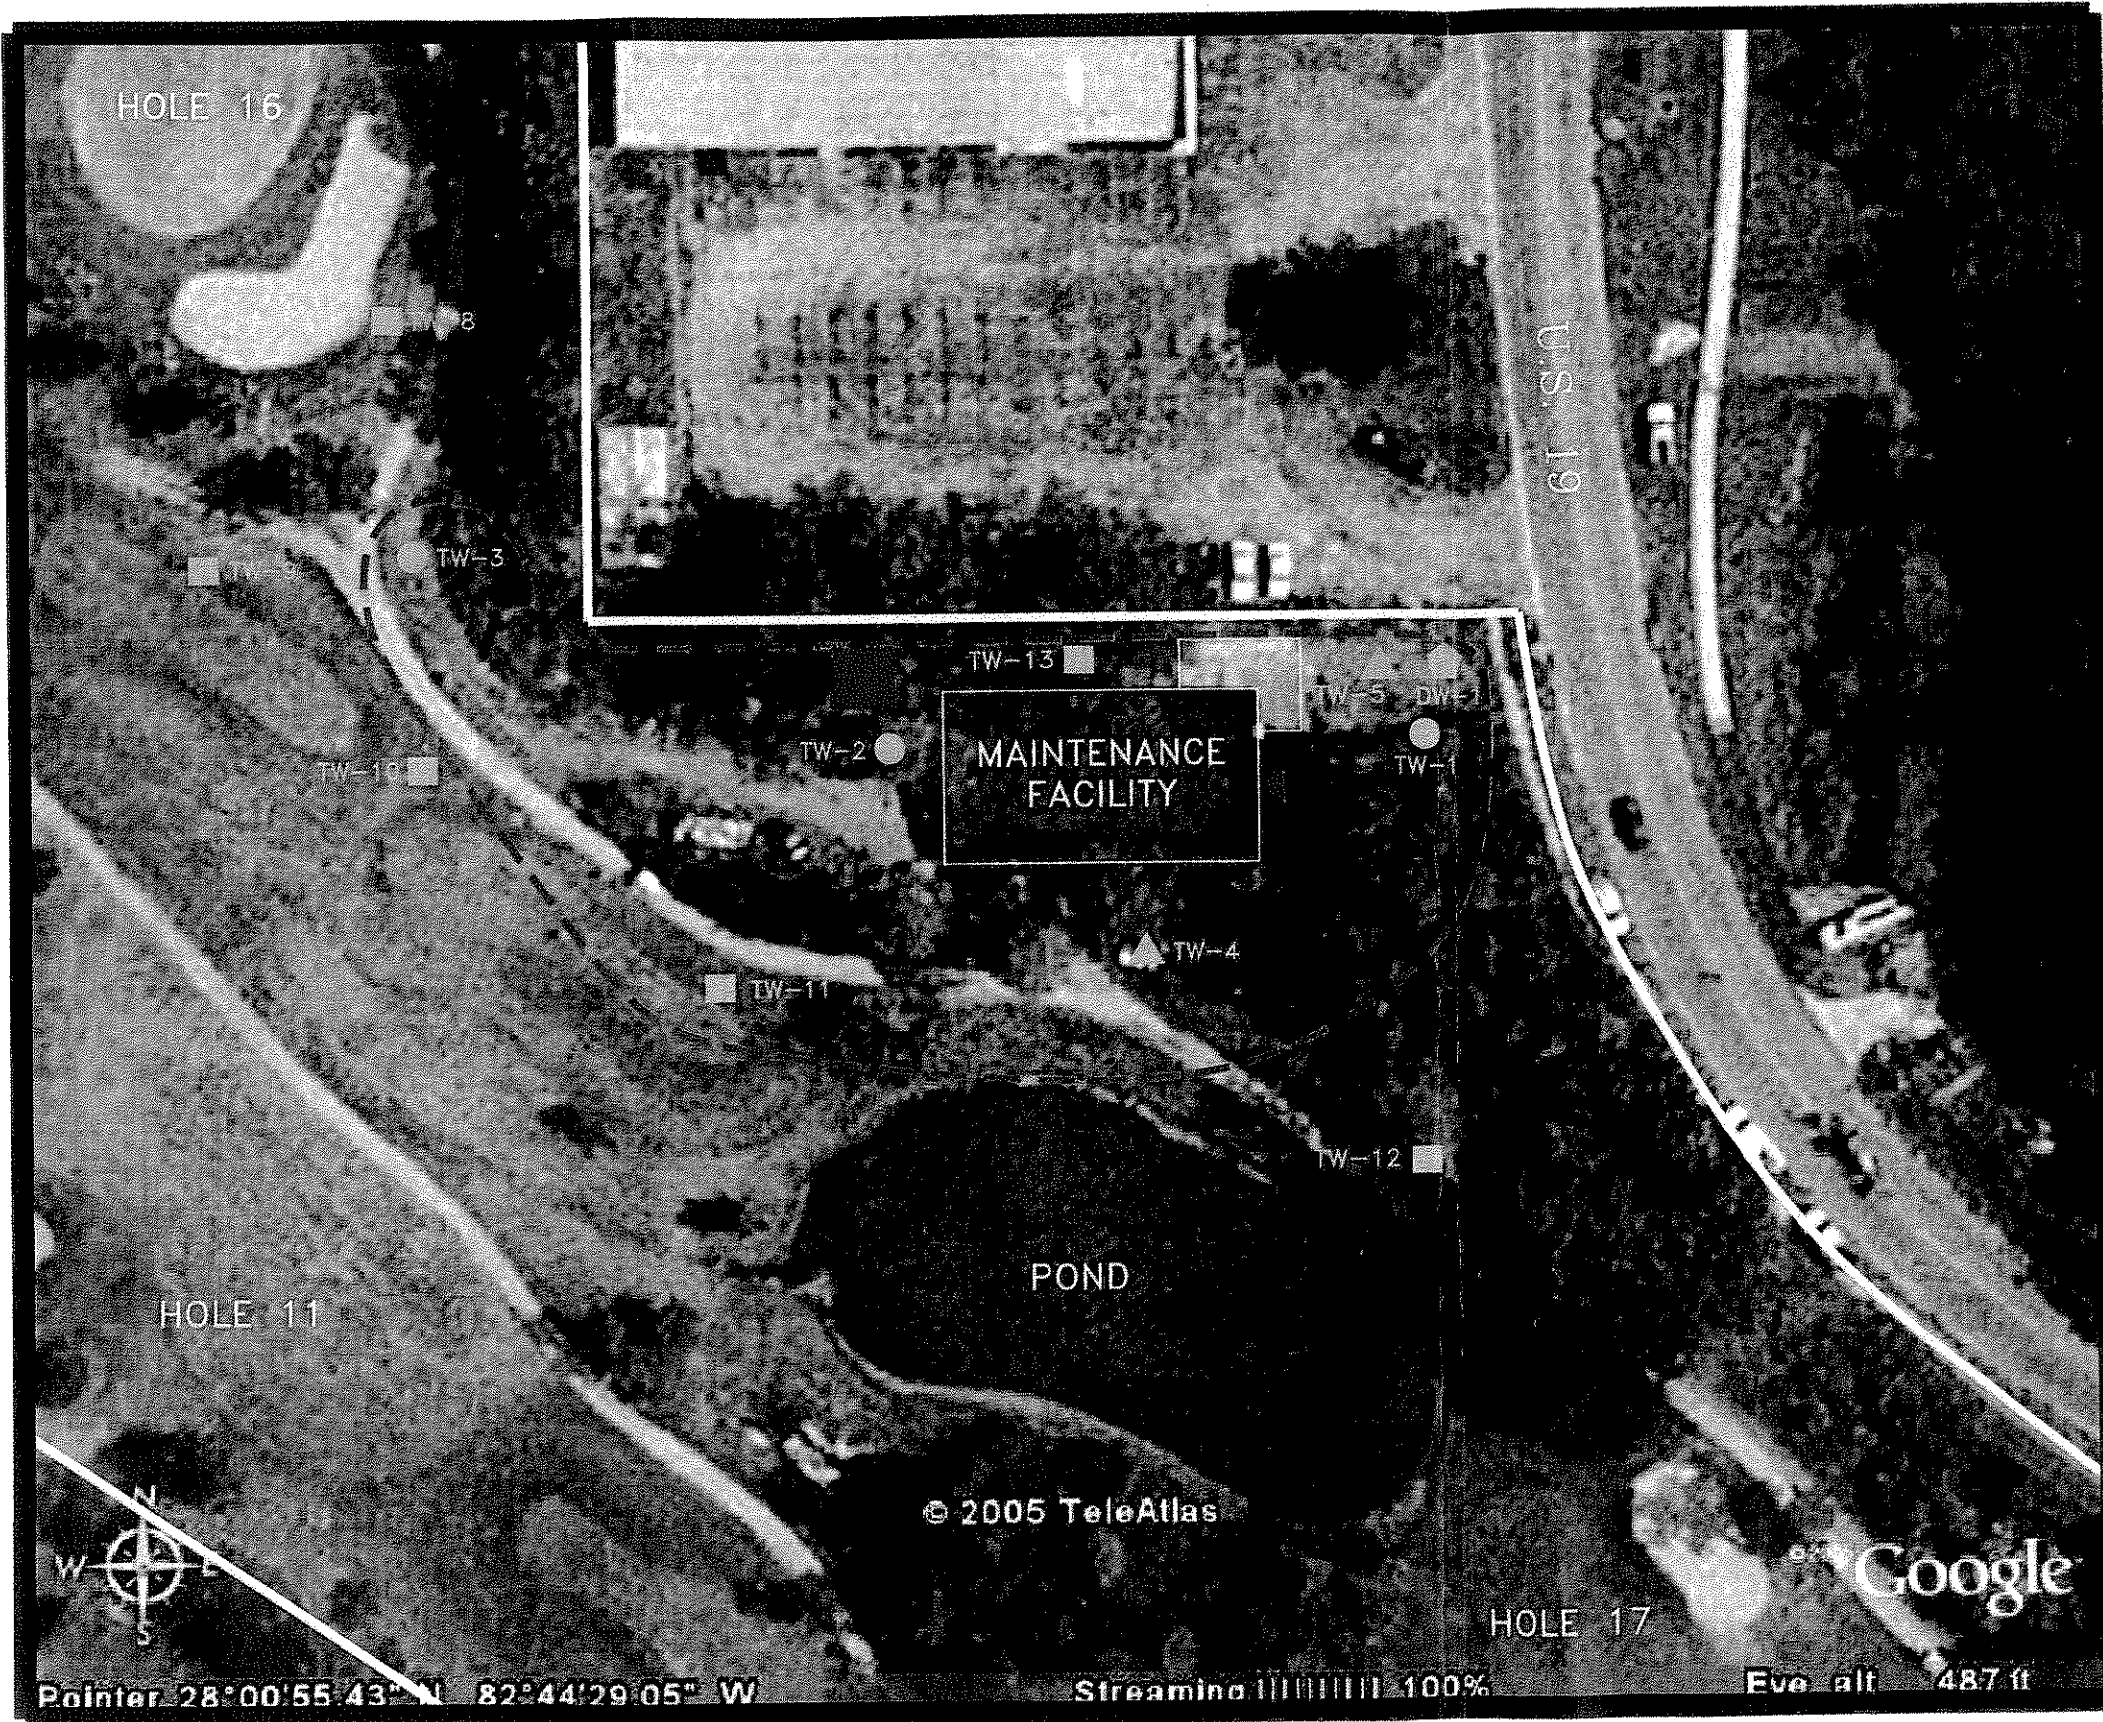
JOB NO.:	601598200
DATE:	7/5/06
CAD NO.:	598200-02
DESIGNED	N/A
DRAWN	SBW
CHECKED	BM
SHEET TITLE GROUNDWATER SAMPLING LOCATION PLAN (MAINTENANCE FACILITY)	
FIGURE 3

- AST ■ ABOVEGROUND STORAGE TANK LOCATION
- TEMPORARY MONITOR WELL LOCATIONS (TW-1-TW-3) INSTALLED AUGUST 27, 2004
- ▲ TEMPORARY MONITOR WELL LOCATIONS (TW-4-TW-7) INSTALLED OCTOBER 6, 2004
- TEMPORARY MONITOR WELL LOCATIONS (TW-8-TW-13) INSTALLED NOVEMBER 12, 2004
- ◆ DEEP MONITOR WELL LOCATION (DW-1) INSTALLED JULY 5, 2005
- — — APPROXIMATE EXTENT OF ARSENIC GROUNDWATER IMPACTS ABOVE THE GROUNDWATER CLEAN UP TARGET LEVEL (GCTL) AS ESTABLISHED IN CHAPTER 62-777, F.A.C.

Groundwater quality in the immediate vicinity of the maintenance facility also exhibited elevated arsenic concentrations. A summary of groundwater arsenic analytical results for the immediate vicinity of the maintenance facility is included as **Table 2**. A groundwater sampling location plan (maintenance facility) is included as **Figure 3**. Groundwater arsenic concentrations varied from below laboratory reporting levels to 540 ug/L. Based on the most recent analytical data, the highest concentrations of arsenic detected in the vicinity of the maintenance facility were

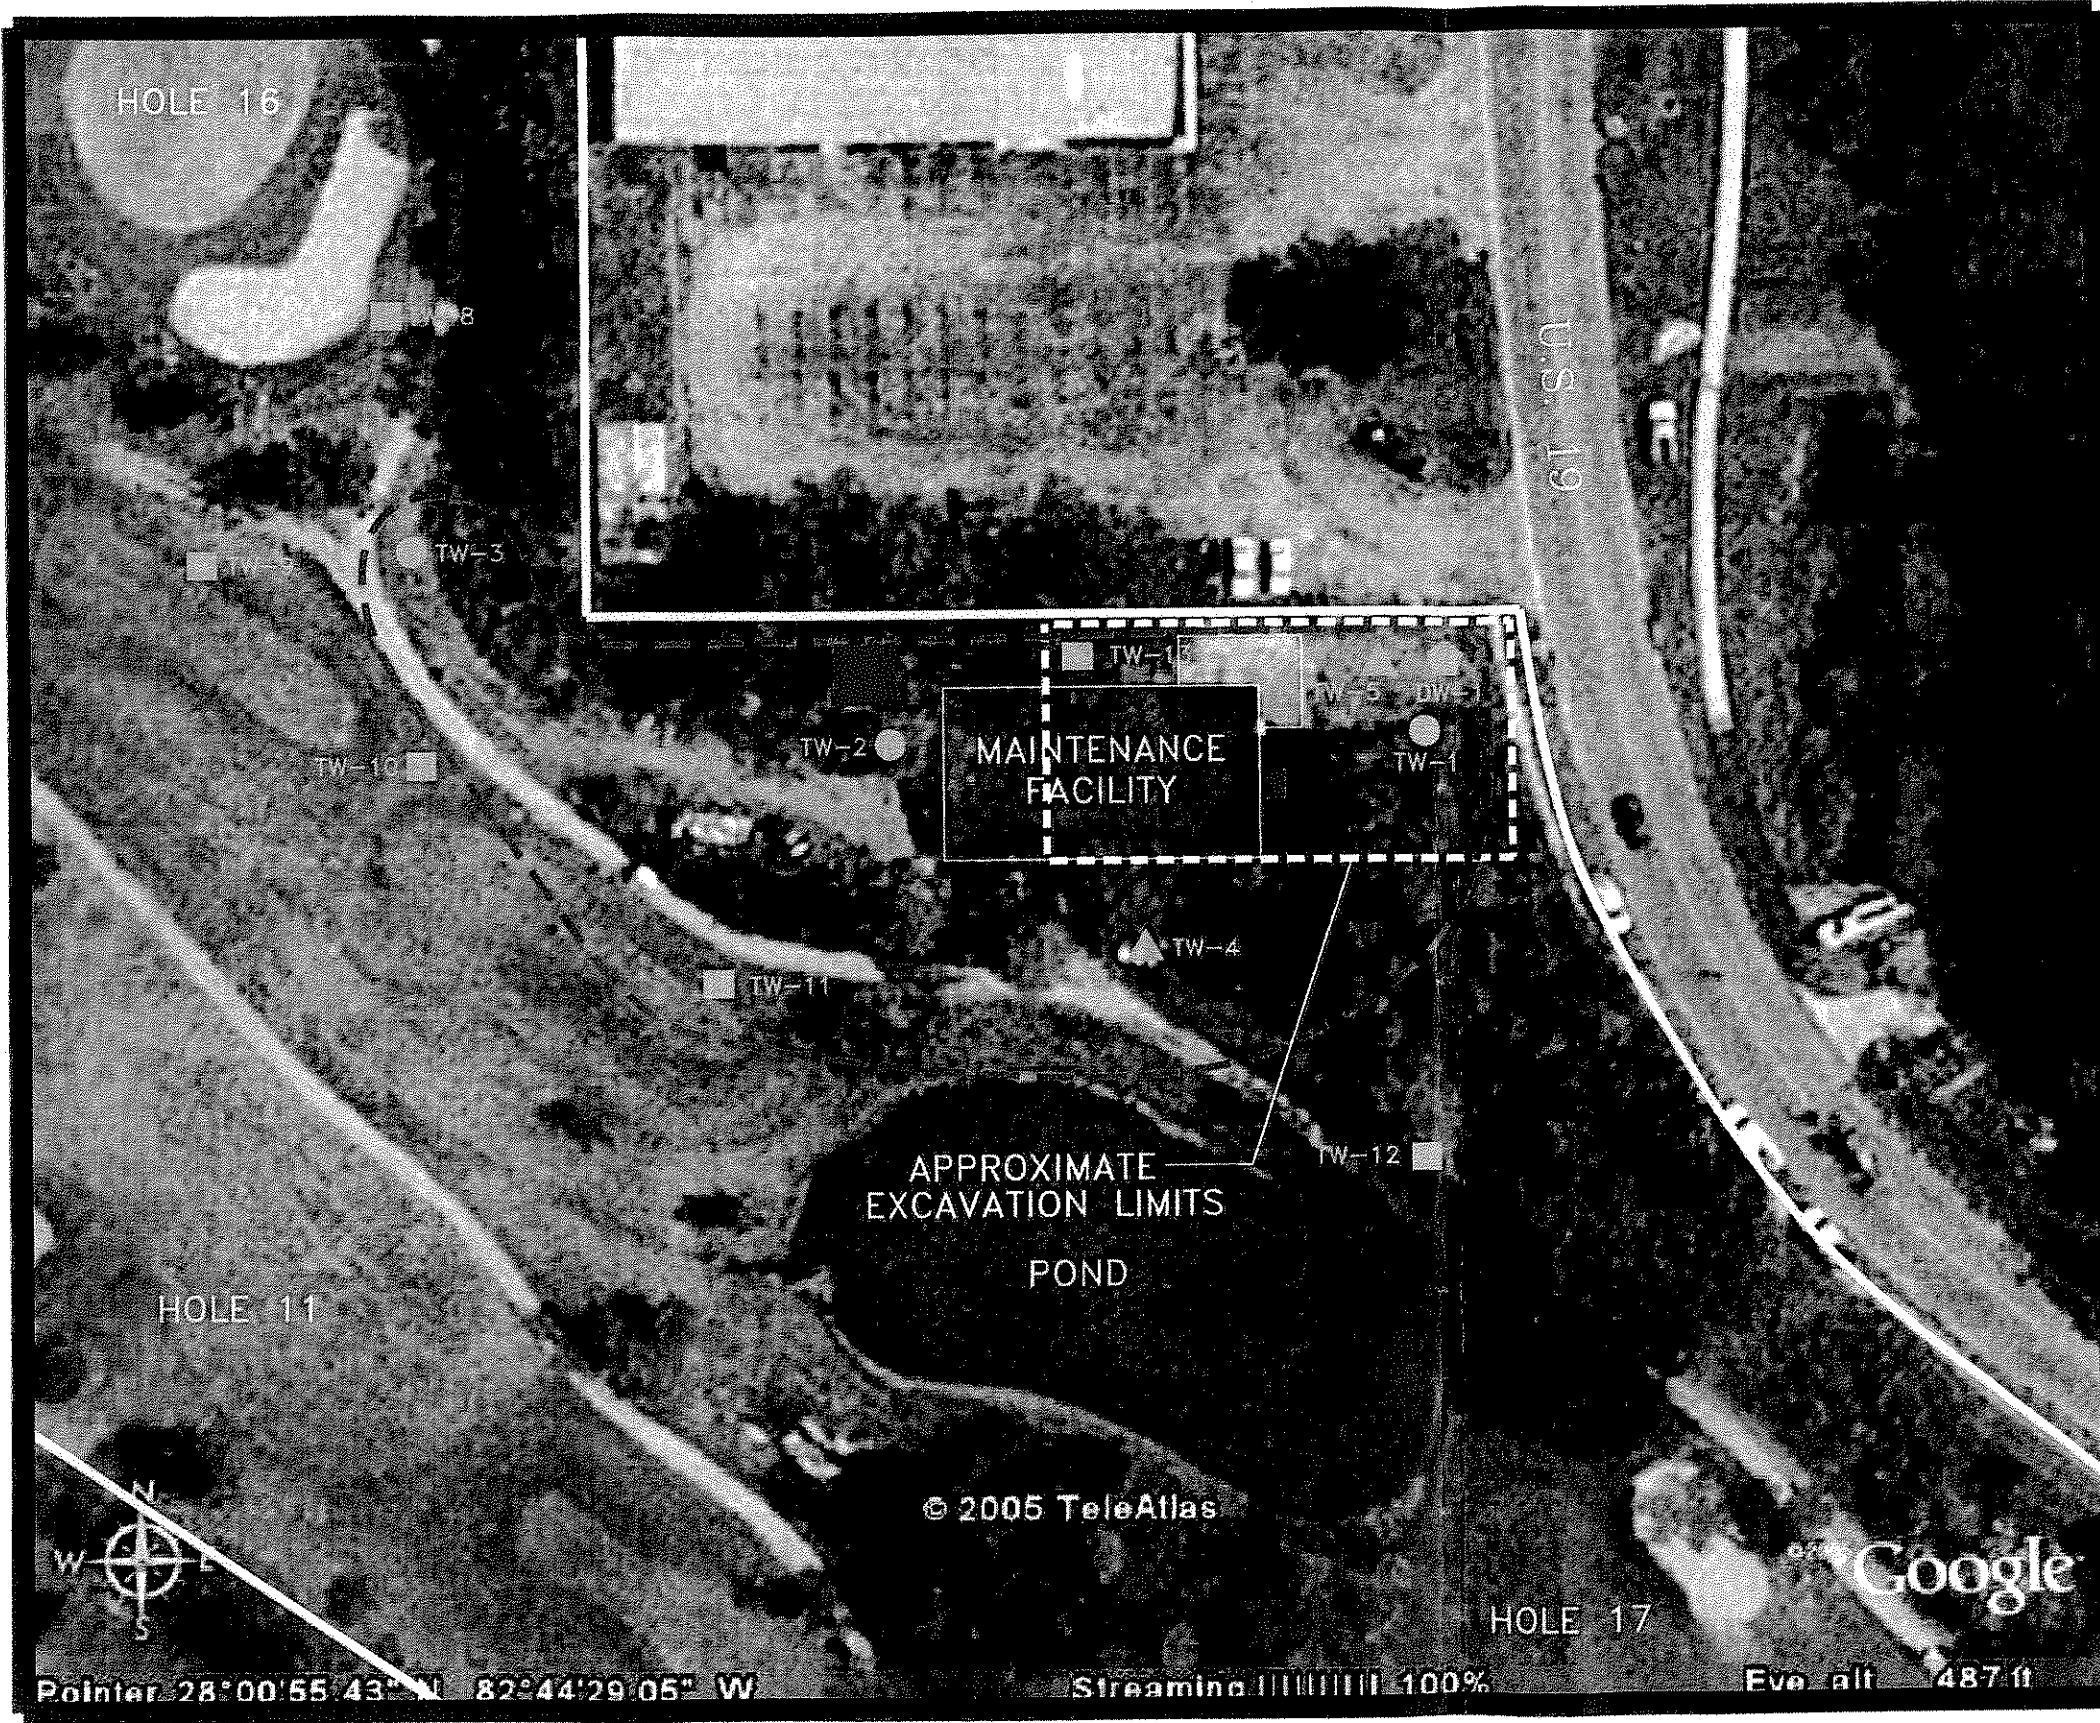
FIGURE 4

SHEET TITLE  
SOIL EXCAVATION PLAN

As presented above, arsenic-impacted soils exist in the vicinity of the maintenance facility located on the subject property. HSA proposes the excavation of the arsenic-impacted soil throughout the maintenance facility area. Based upon soil and groundwater analytical data gathered from the vicinity of the maintenance facility, the majority of the impacts appear to be located to the east and northeast of the existing structure. As such, an area approximately 70 feet by 120 feet has been selected for excavation. The proposed extent of excavation is depicted in **Figure 4**. Soil excavation will occur to the water table, which is expected to be encountered within five feet of land surface.

Prior to excavation, all surface encumbrances that are located so as to create a hazard to employees shall be removed or supported, as necessary, to safeguard employees. The impacted soil will be excavated using a backhoe excavator and stockpiled on-site prior to off-site disposal. A proposed excavation plan depicting the location of the proposed stockpile area is included as **Figure 4**. A minimum side slope of 1:1 will be maintained, where possible, to prevent cave-in of soils from around the excavation.
